ธรณีวิทยาทางทะเลและกระบวนการกัดเซาะชายฝั่งอ่าวพัทยา ภาคตะวันออกประเทศไทย

วิทยานิพนธ์นี้เป็นส่วนหนึ่งของการศึกษาตามหลักสูตรปริญญาวิทยาศาสตรมหาบัณฑิต

MARINE GEOLOGY AND COASTAL EROSION PROCESSES OF PATTAYA BAY, EASTERN  
THAILAND

Thesis Title	MARINE GEOLOGY AND COASTAL EROSION PROCESSES OF PATTAYA BAY, EASTERN THAILAND
By	Miss Inthurat Hlaongam
Field of Study	Earth Sciences
Thesis Advisor	Professor Thanawat Jarupongsakul, Ph.D.

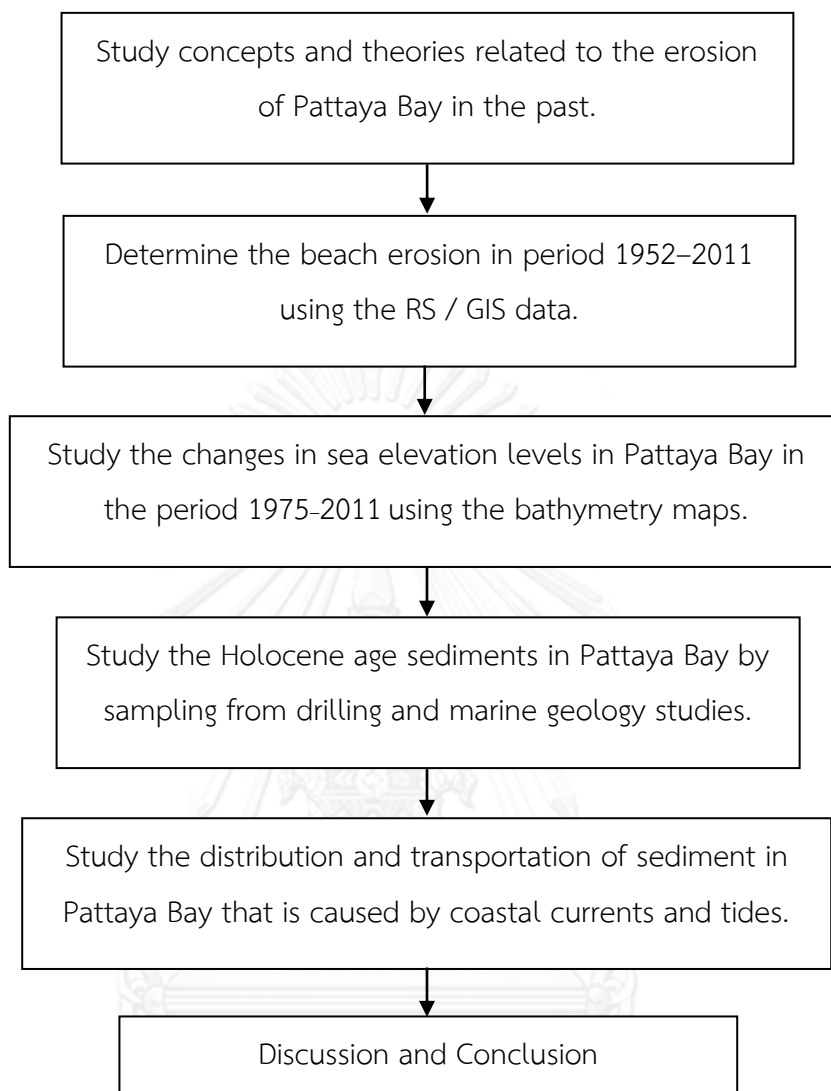
**Figure 1** Algorithm of the approach used in this study.

In this study of the coastal erosion process at Pattaya Bay, geographic information, marine geology, meteorology, hydro-oceanography, coastal engineering and geomorphology were used together to carefully describe the erosion phenomena of Pattaya Bay. All these information were compiled into a new consensus sequence including a comparative analysis and evaluation to find the main causes of the coastal erosion of Pattaya Bay. In addition, sediments were collected from the shore to offshore region of Pattaya Bay in each of the two monsoon seasons to evaluate the distribution of the sediments, which were then displayed graphically to compare the sediment patterns and any seasonal changes. The results of the field data helped to explain the erosion phenomenon. The approach taken to evaluate the studies and results of the Pattaya Bay erosion from past to present are summarized in the algorithm shown in Figure 1.

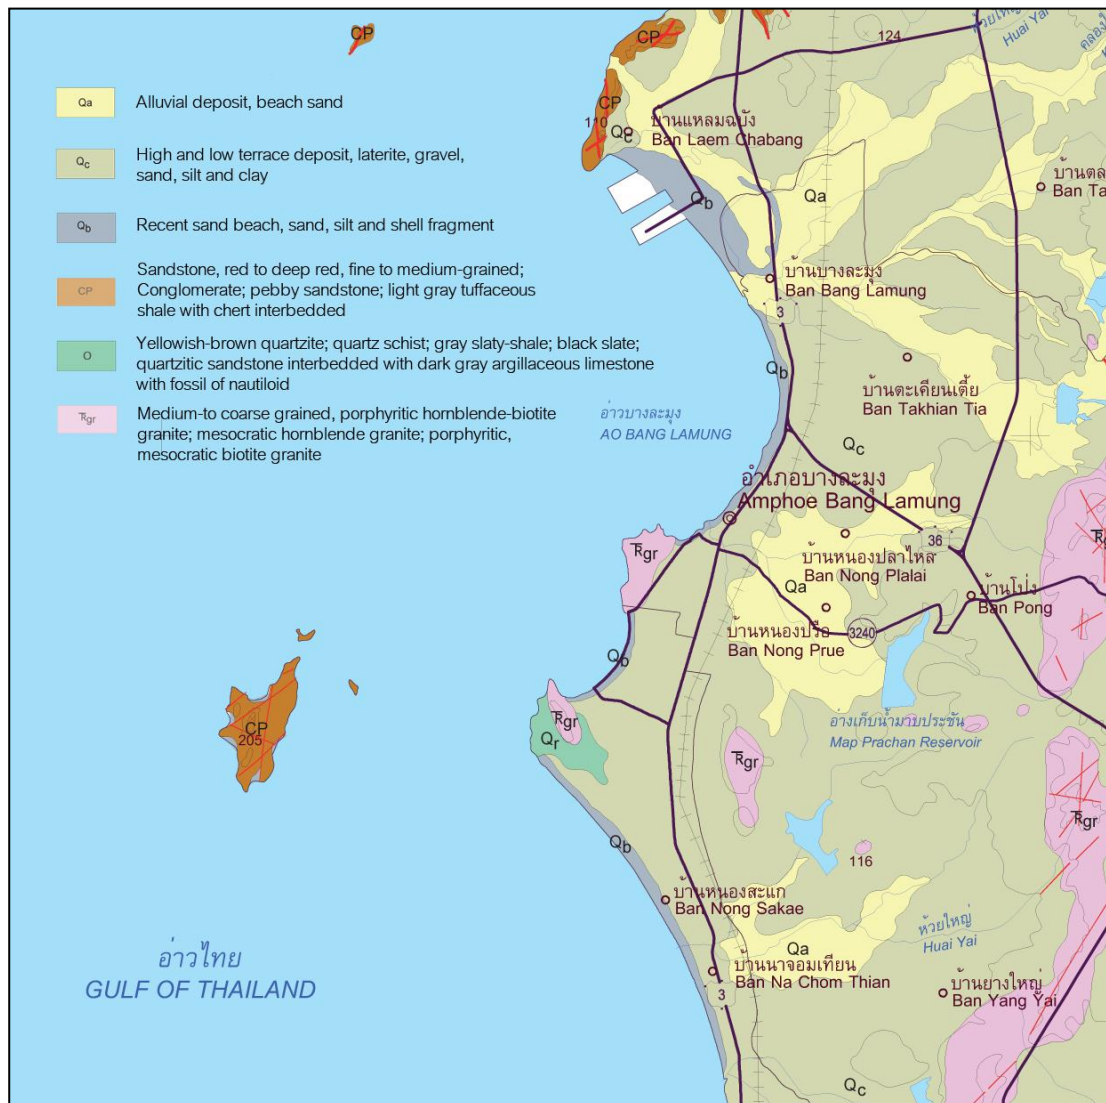
Figure 5 Geologic map of Pattaya Bay

(adapted from geologic map scale 1:250,000 DMR, 1976) (17)

**2.4.5. O : Yellowish-brown quartzite; quartz schist; gray slaty-shale; black slate; quartzitic sandstone interbedded with dark gray argillaceous limestone with fossil of nautiloid.** This feature can be found at Pattaya Cape, south Pattaya. It formed in the Carboniferous age. Fossils are dominantly in this feature with dark color.

**2.4.6. Rgr : Medium to coarse grained, porphyritic hornblende-biotite granite; mesocratic biotite granite.** Igneous rock formed in the Triassic period and is commonly found along the coast. In the Pattaya Bay region, it can be seen at Pattaya Cape and Wong-amart Bay, especially in Wong-amart Bay at the north of Pattaya Bay.

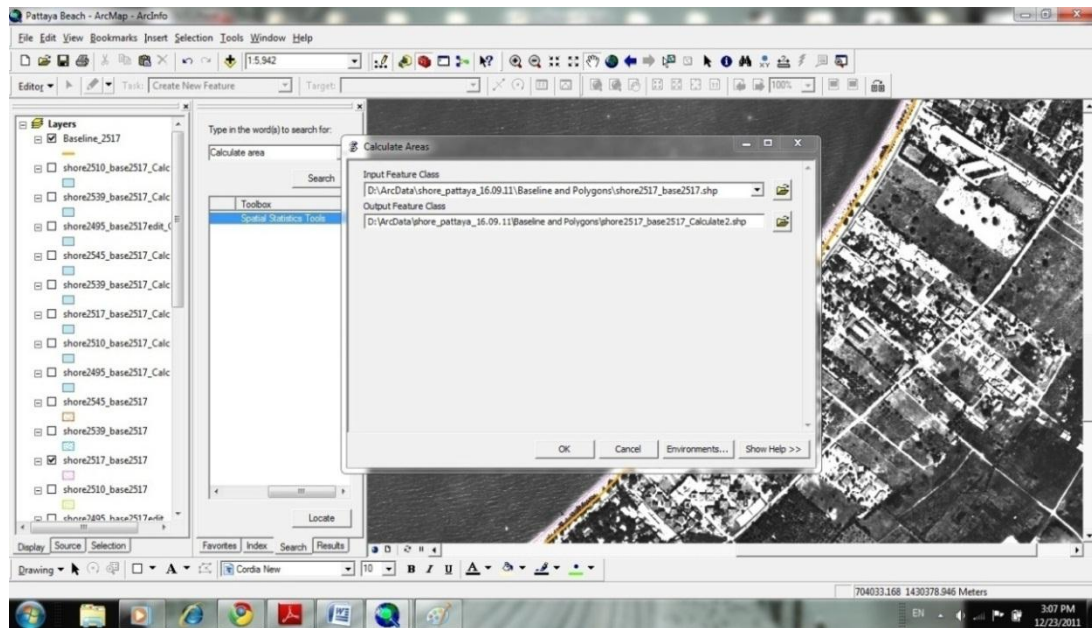
**Figure 14** Spatial data layer (blue lined polygon) after using the "Calculate area" command.

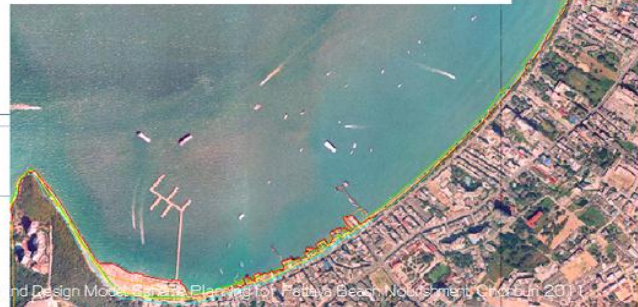
Figure 15 The beach width and area of Pattaya Bay in 1952–2011.

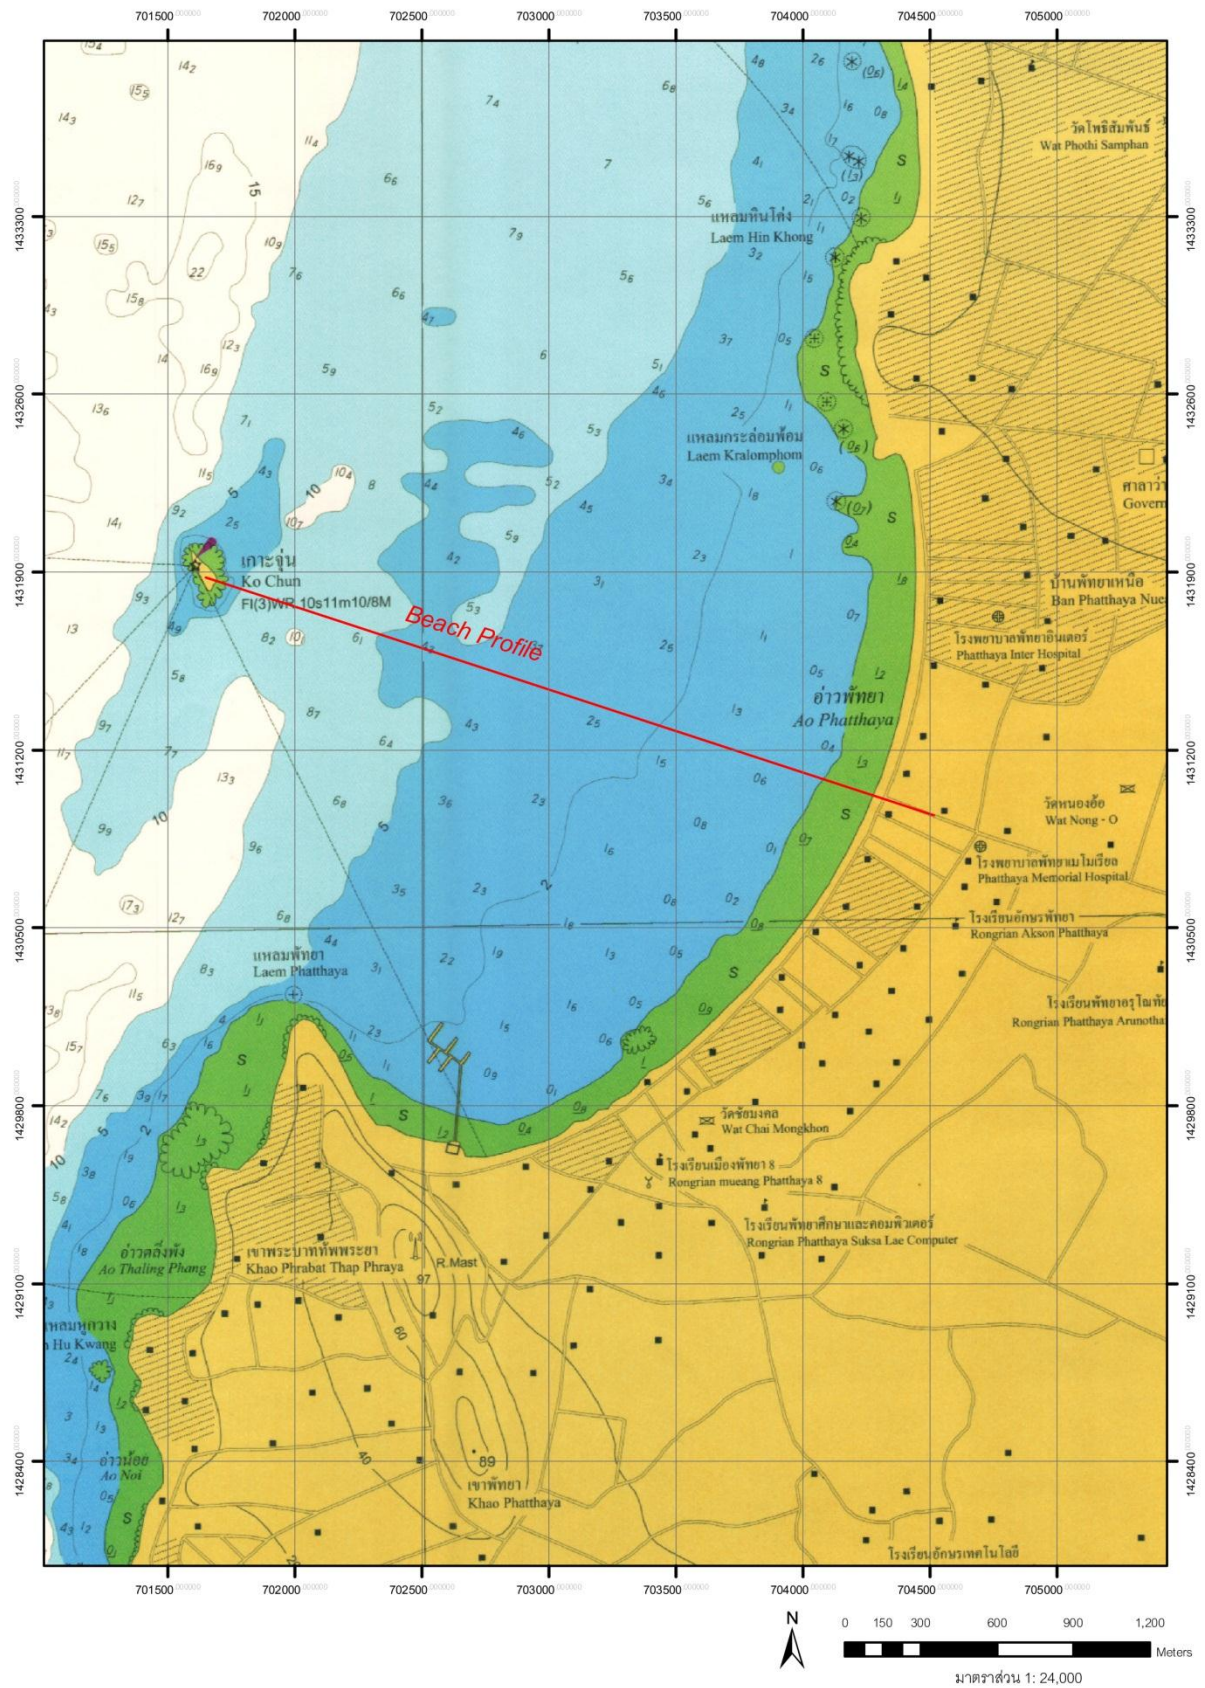
Figure 17 Bathymetry map for 1975 (data from Royal Thai Navy)

Figure 18 Bathymetry map for 1983 (data from Royal Thai Navy)

Figure 19 Bathymetry map for 1988 (data from Royal Thai Navy)

Figure 20 Bathymetry map for 1995 (data from Royal Thai Navy)

Figure 21 Bathymetry map for 2000 (data from Royal Thai Navy)

Figure 22 Bathymetry map for 2009 (data from Royal Thai Navy)

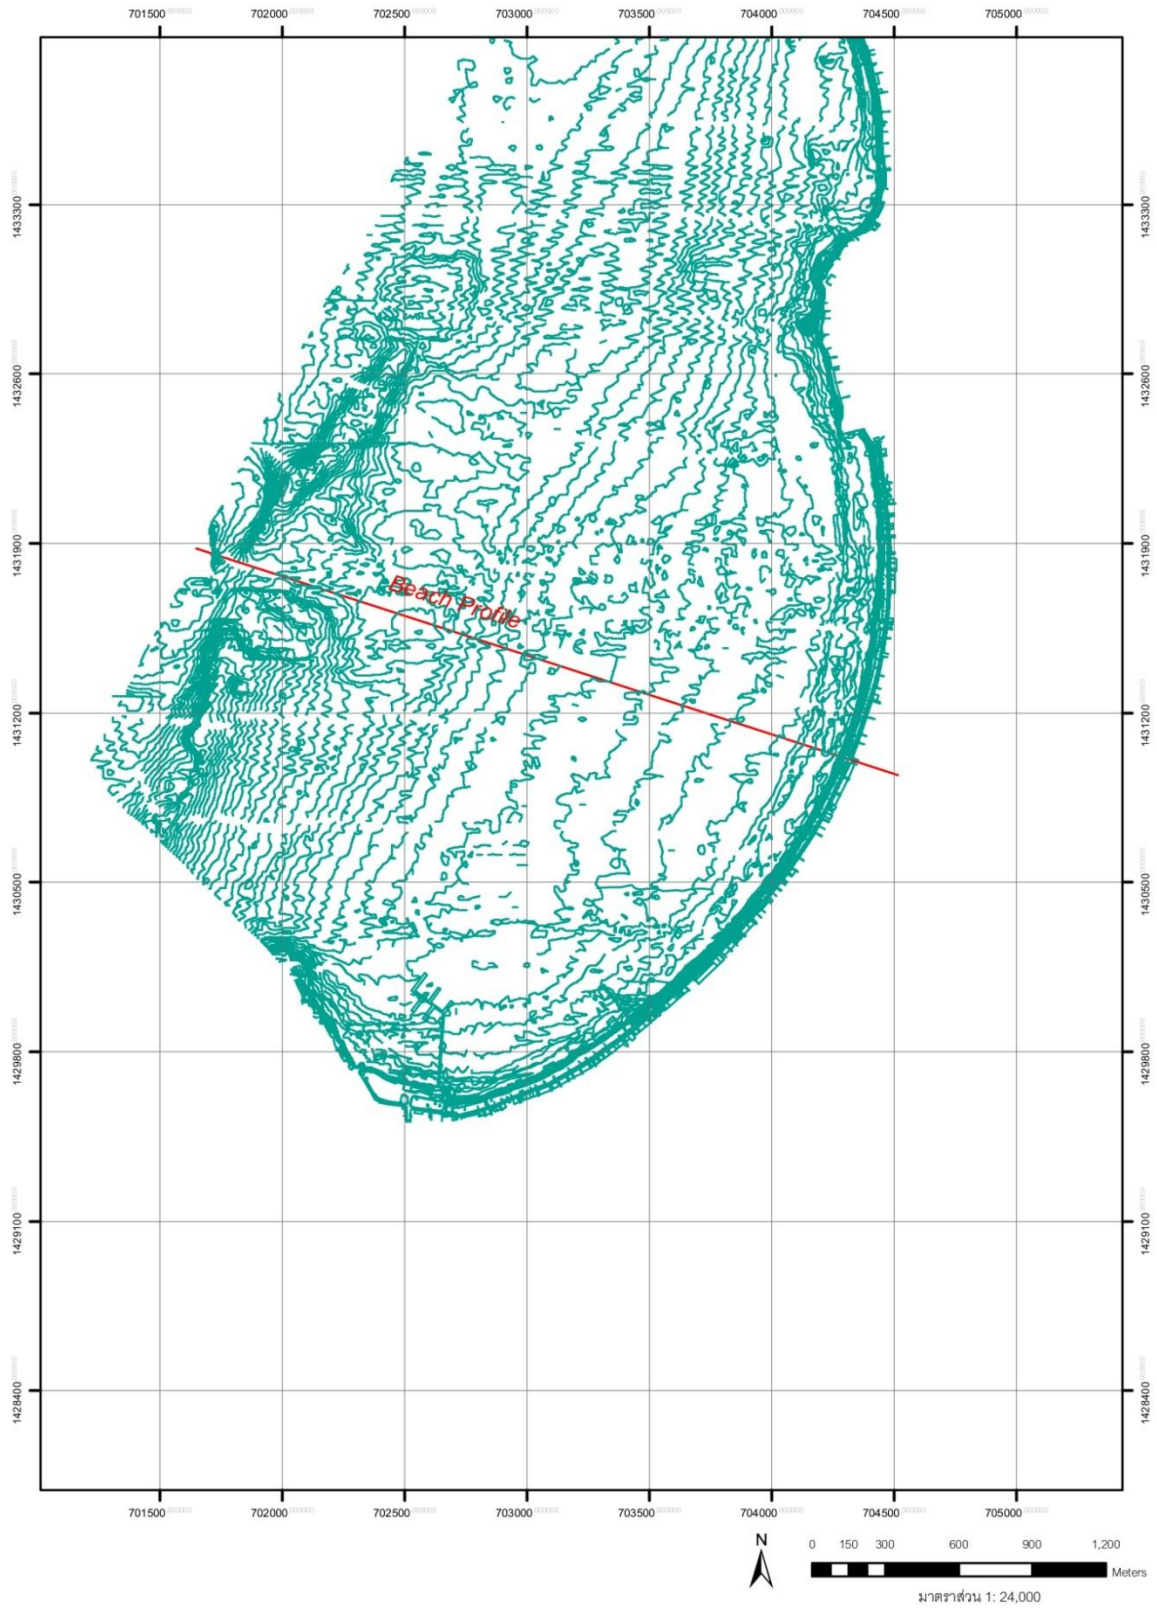
Figure 23 Digital bathymetry map for 2003 (data by Team Consulting Management Co. Ltd.)

Figure 24 Digital bathymetry map for 2011 (data by Team Consulting Engineering and Management Co. Ltd.)

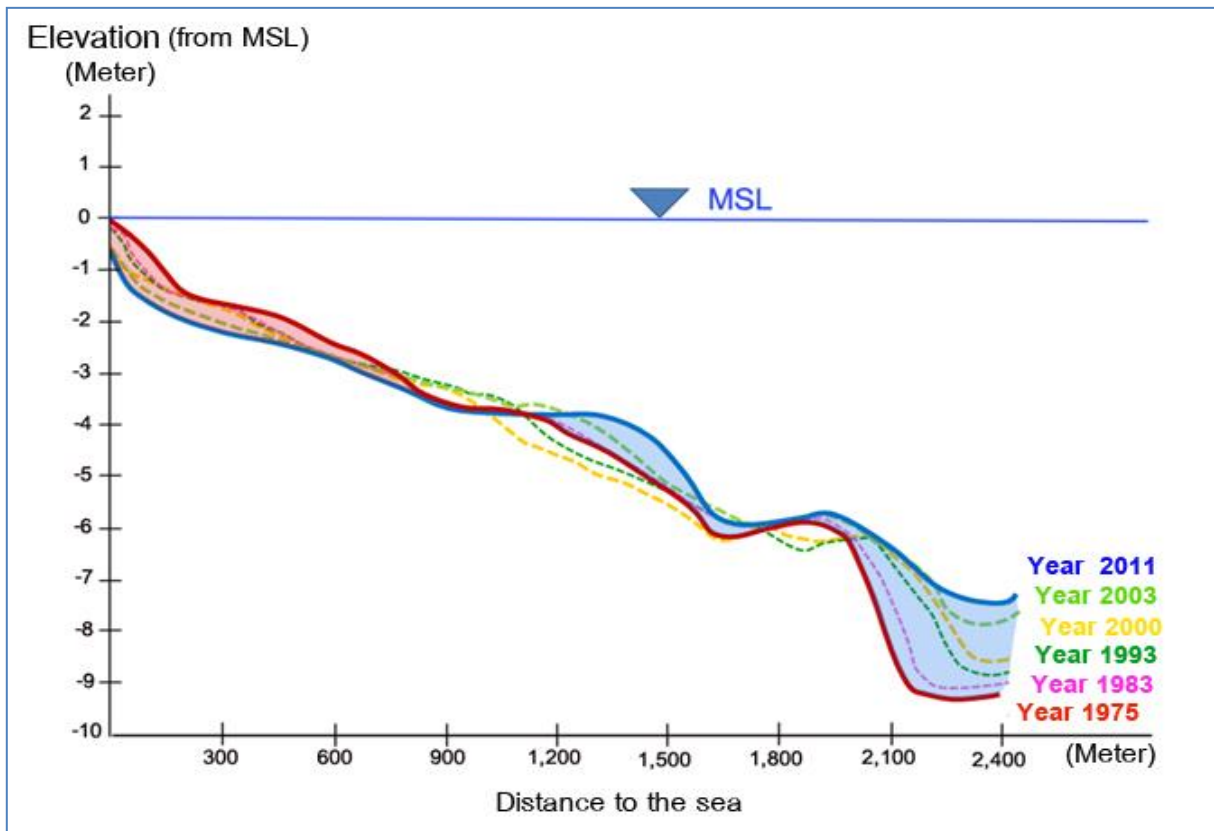
Figure 25 Beach profile of Pattaya Bay from central Pattaya to Koh Jun between 1975 and 2011, showing the eroded area (red color) and accumulated area (blue color). (Map scale: 1:24,000; vertical exaggeration = 240x).

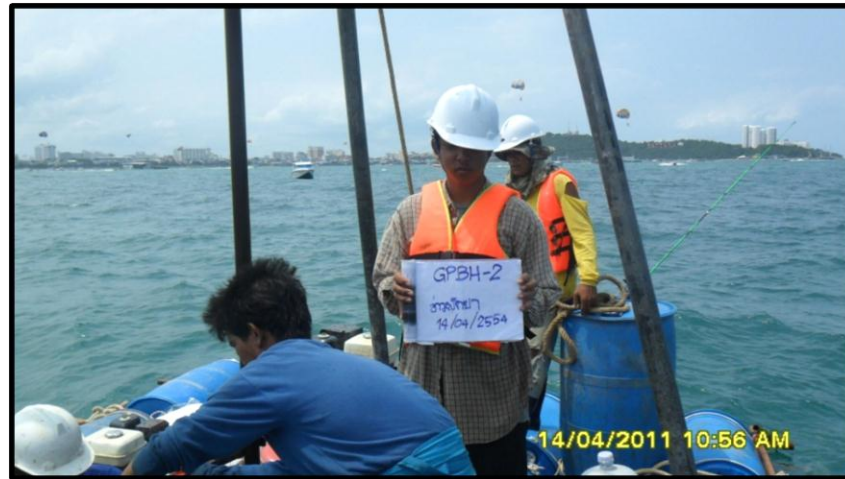
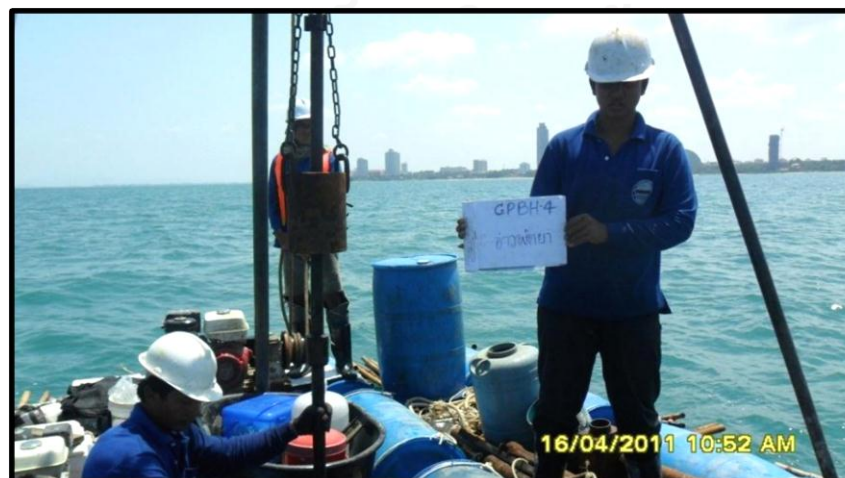
Figure 27 Borehole sampling in Pattaya Bay

Figure 29 Another borehole sampling in Pattaya Bay.

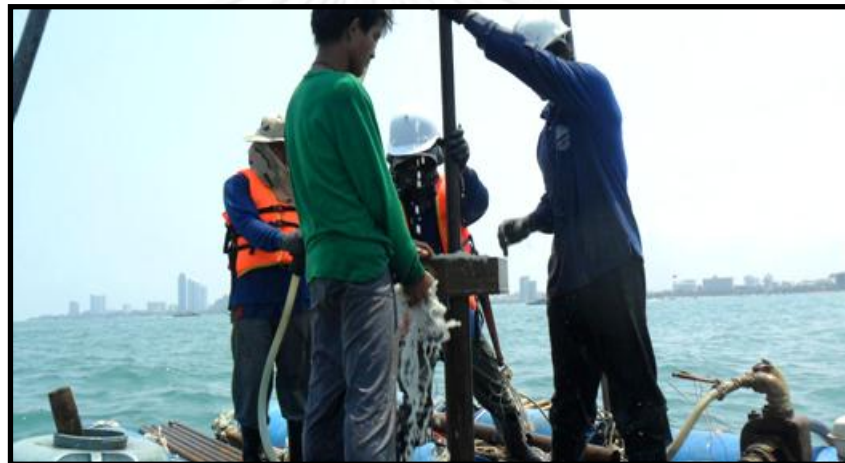
Figure 28 Counter flush reverse circulation.

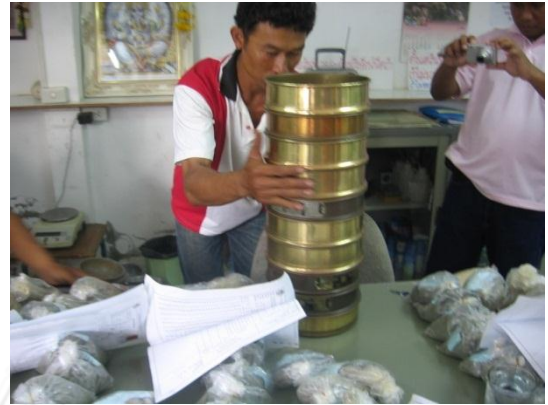
**Figure 31** Sieve analysis of the  
sediment samples.

The sampled sediment was tested by sieve analysis, from which it was found that borehole numbers 2, 3, 5, 7, 8, 10, 11 and 12 had a large proportion of sand particles. Both BH-3 and BH-6 have sand in the deep layer, while BH-10 had gravel and sand particles accumulated throughout its depth. According to the results from the borehole data, the distribution of offshore sand particles in Pattaya Bay is consistent with the results of the Department of Mineral Resources in 2011, which reported sand dunes offshore of Pattaya Bay. This sand was Holocene sediment (see section 4.3). However, the test results showed that the distribution of sand particles in these boreholes had a proportion of clay mixed in every borehole. Therefore, these particles, which are black, are not suitable to be used as beach sand. Hence, this sand is of no use for the Project of Survey and Design Model Scheme Planning for Pattaya Beach Nourishment, Chonburi (2011), which advocated bringing offshore sand to build artificial beaches at Pattaya Bay.

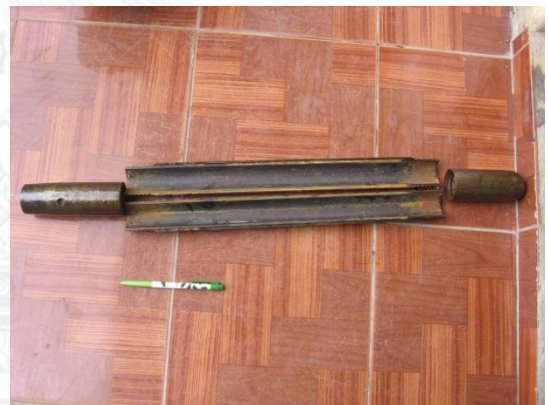
**Figure 32** Drilling head of the lighter  
type (Motorind Cathead)

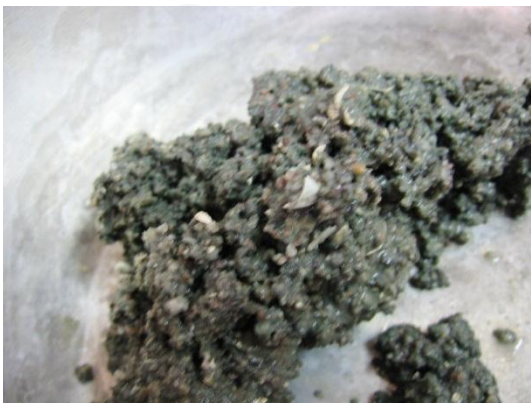
**Figure 35** Offshore sandy mud in a  
deep layer of the borehole

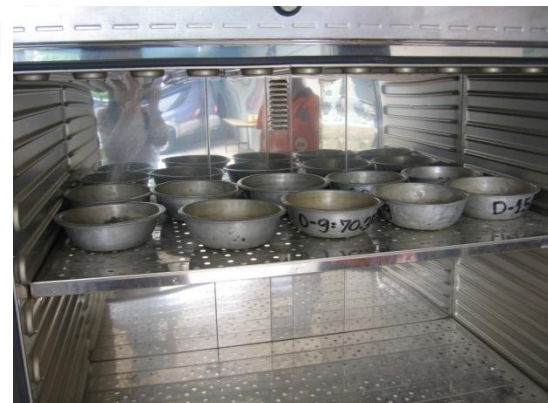
**Figure 34** Drying the samples in an  
oven

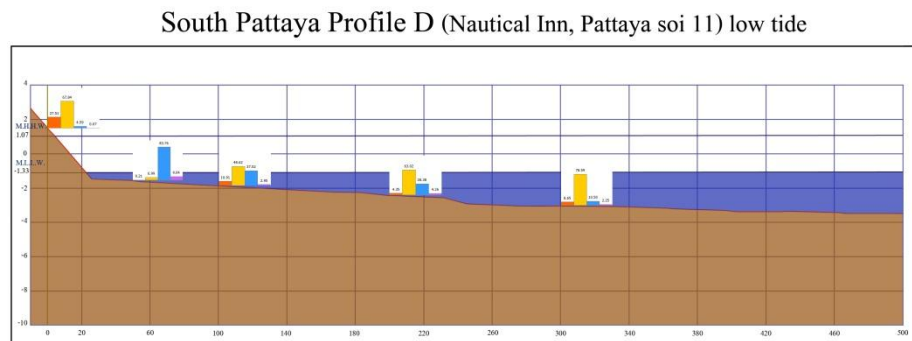
(4). Profile D: South Pattaya STA.1+750 (Nautical Inn, Pattaya soi 11 Rd.)

**Figure 54** Profile D of Pattaya Bay at the mean higher high water level (MHHW).

**Figure 55** Profile D of Pattaya Bay at the mean lower low water level (MLLW).
