EVALUATION OF LANDSLIDE OCCURRENCE USING  
HYDROLOGICAL MODEL IN HUAI NAM PHUNG  
SUBBASIN, THAILAND

A Thesis Submitted in Partial Fulfillment of the Requirements  
for the Degree of Master of Science in Earth Sciences  
Department of Geology  
FACULTY OF SCIENCE  
Chulalongkorn University  
Academic Year 2019  
Copyright of Chulalongkorn University

Thesis Title                                   EVALUATION OF LANDSLIDE OCCURRENCE USING  
HYDROLOGICAL MODEL IN HUAI NAM PHUNG  
SUBBASIN, THAILAND  
By   Acting SubLt. Rugkiet Chansorn  
Field of Study                                 Earth Sciences  
Thesis Advisor                               Associate Professor SRILERT CHOTPANTARAT, Ph.D.  
Thesis Co Advisor                         Pawee Klongvessa, Eng.D.

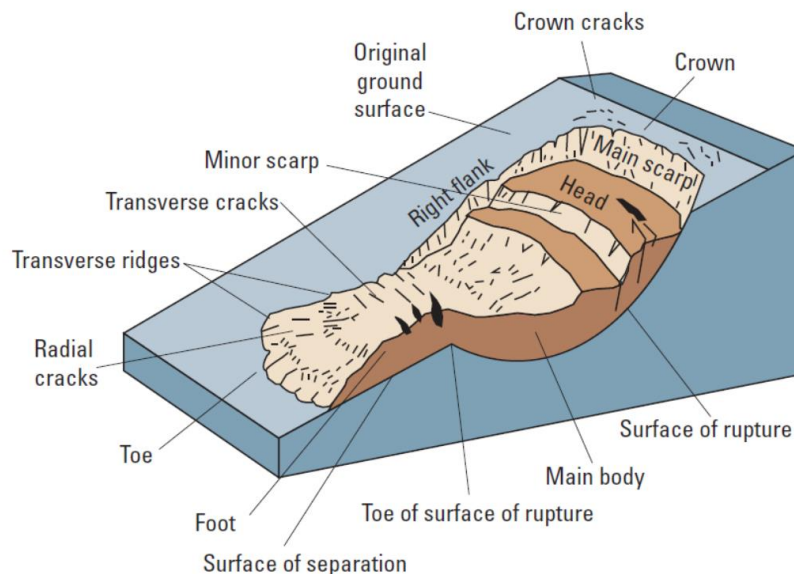
**Figure 2.1** Occurrence of landslides (Highland and Bobrowsky, 2008)

Landslides are a disaster that is caused by the movement of soil masses from high elevation to low elevation on the steep slope area. It causes extensive damage, both in the area where the mass of the soil collapsed and the area where the mass of the soil moved down to cover. It occurs in areas with slopes because the slopes cause the mass of the accumulated soil to move down by the gravity of the earth. The occurrence of landslides results in soil mass covering the area at the bottom of the slope which collapses when the soil mass is unstable (**Figure 2.1**).

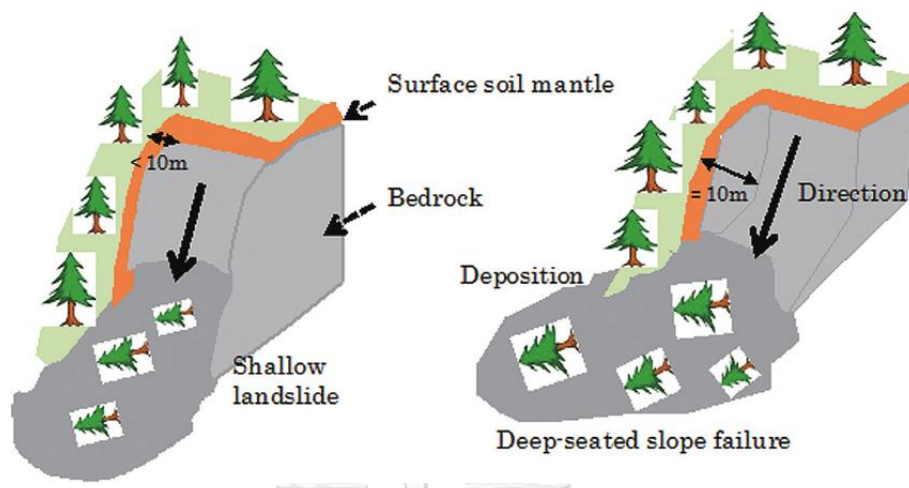
**Figure 2.2** Landslide classification by soil mantle that covering bedrock (Dou et al., 2015)

The landslides which occur in cliff or high slope areas can be classified into 2 types, shallow landslide and deep-seated failure (Dou et al., 2015). If the thickness of surface soil mantle that covers bedrock is lower than 10 meters, it is classified as the shallow landslide. On the other hand, if the thickness of surface soil mantle that

covers bedrock is higher than 10 meters, it is classified as the deep-seated failure (Figure 2.2).

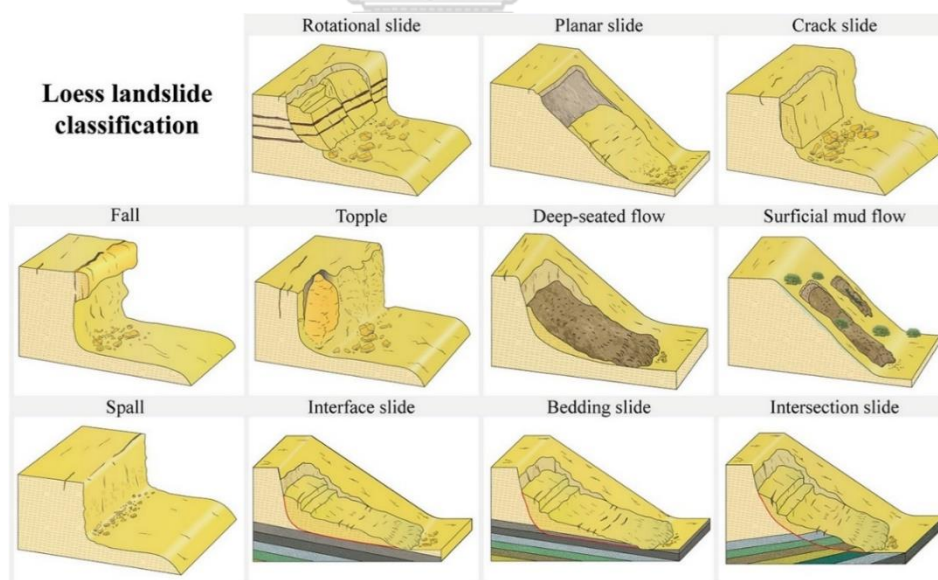
**Figure 2.3** Loess landslide classification (Li and Mo, 2019)

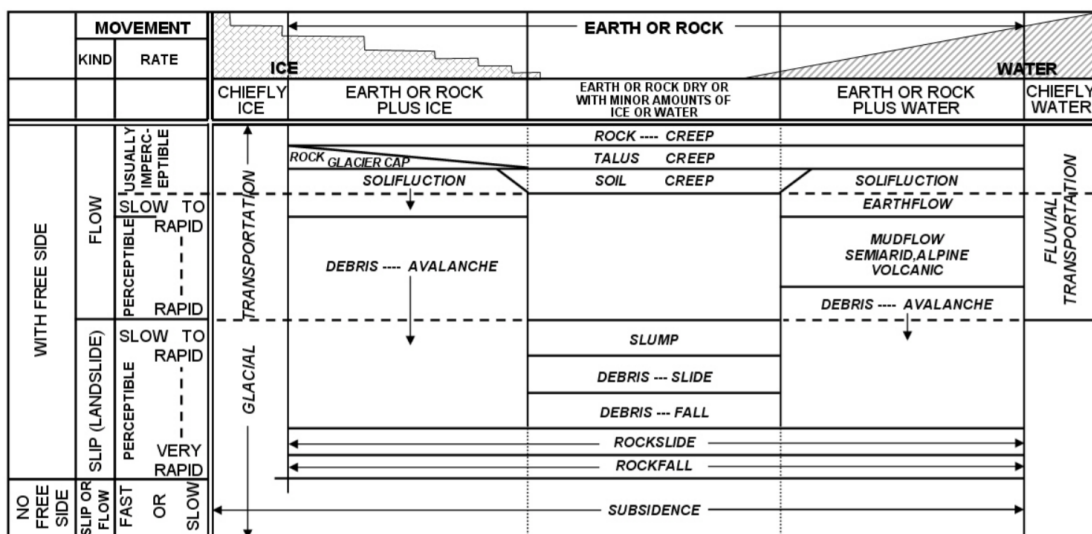
Figure 2.4 Schematic diagram of the landslide classification system (Sharpe, 1938)

The landslides occur in the loess slope area can be classified into 11 types, rotational slide, planar slide, crack slide, fall, topple, deep-seated flow, surficial mudflow, spall, interface slide, bedding slide, and intersection slide (Li and Mo, 2019) (Figure 2.3). In addition, landslides can also be classified according to the amount of water and sediments (Sharpe, 1938) (Figure 2.4).

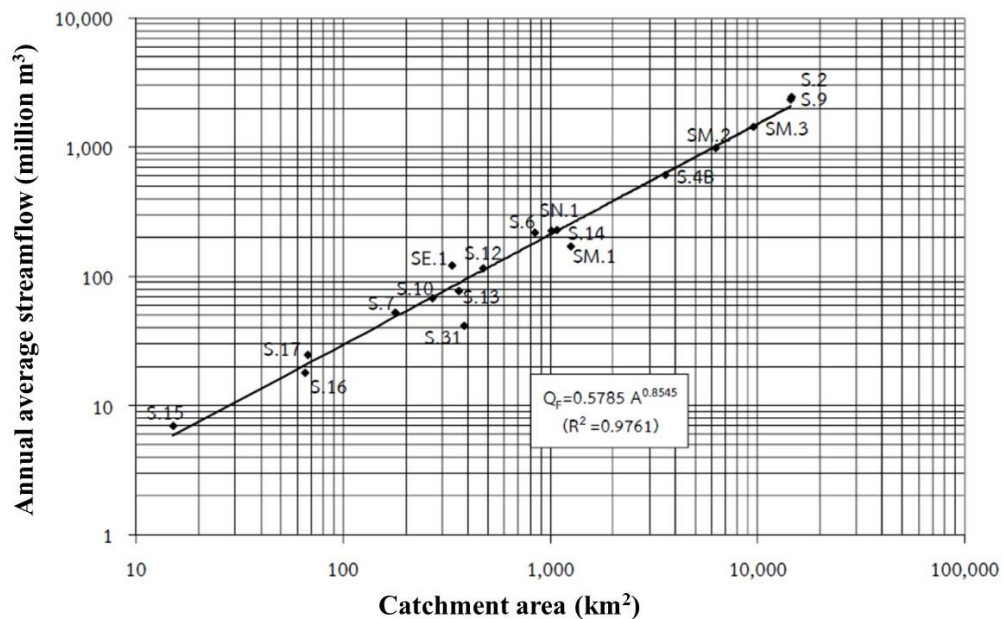
**Figure 3.7** Relationship between annual average streamflow and catchment area (Institute of Water Resources and Agriculture Information Thailand, 2012)

The transferring of the observed streamflow data was following the linear relationship between annual average streamflow and catchment area.

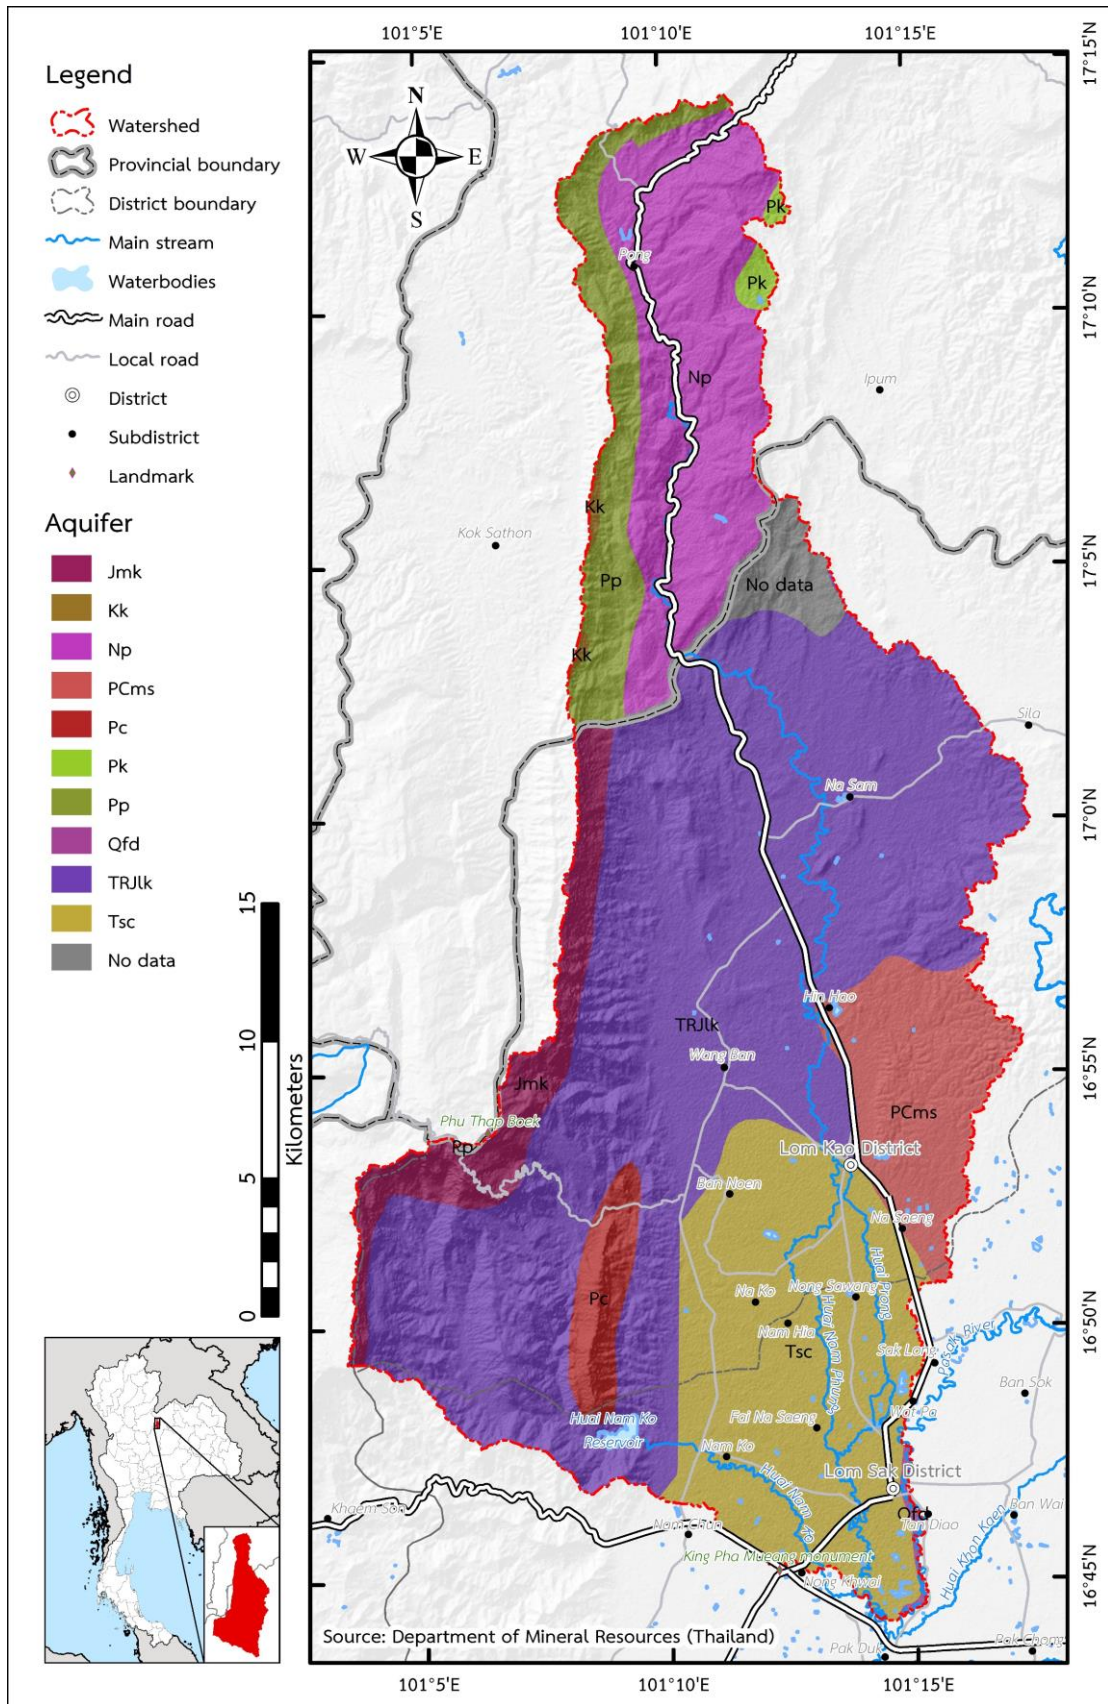
**Figure 3.9** Hydrogeological map of the Huai Nam Phung subbasin

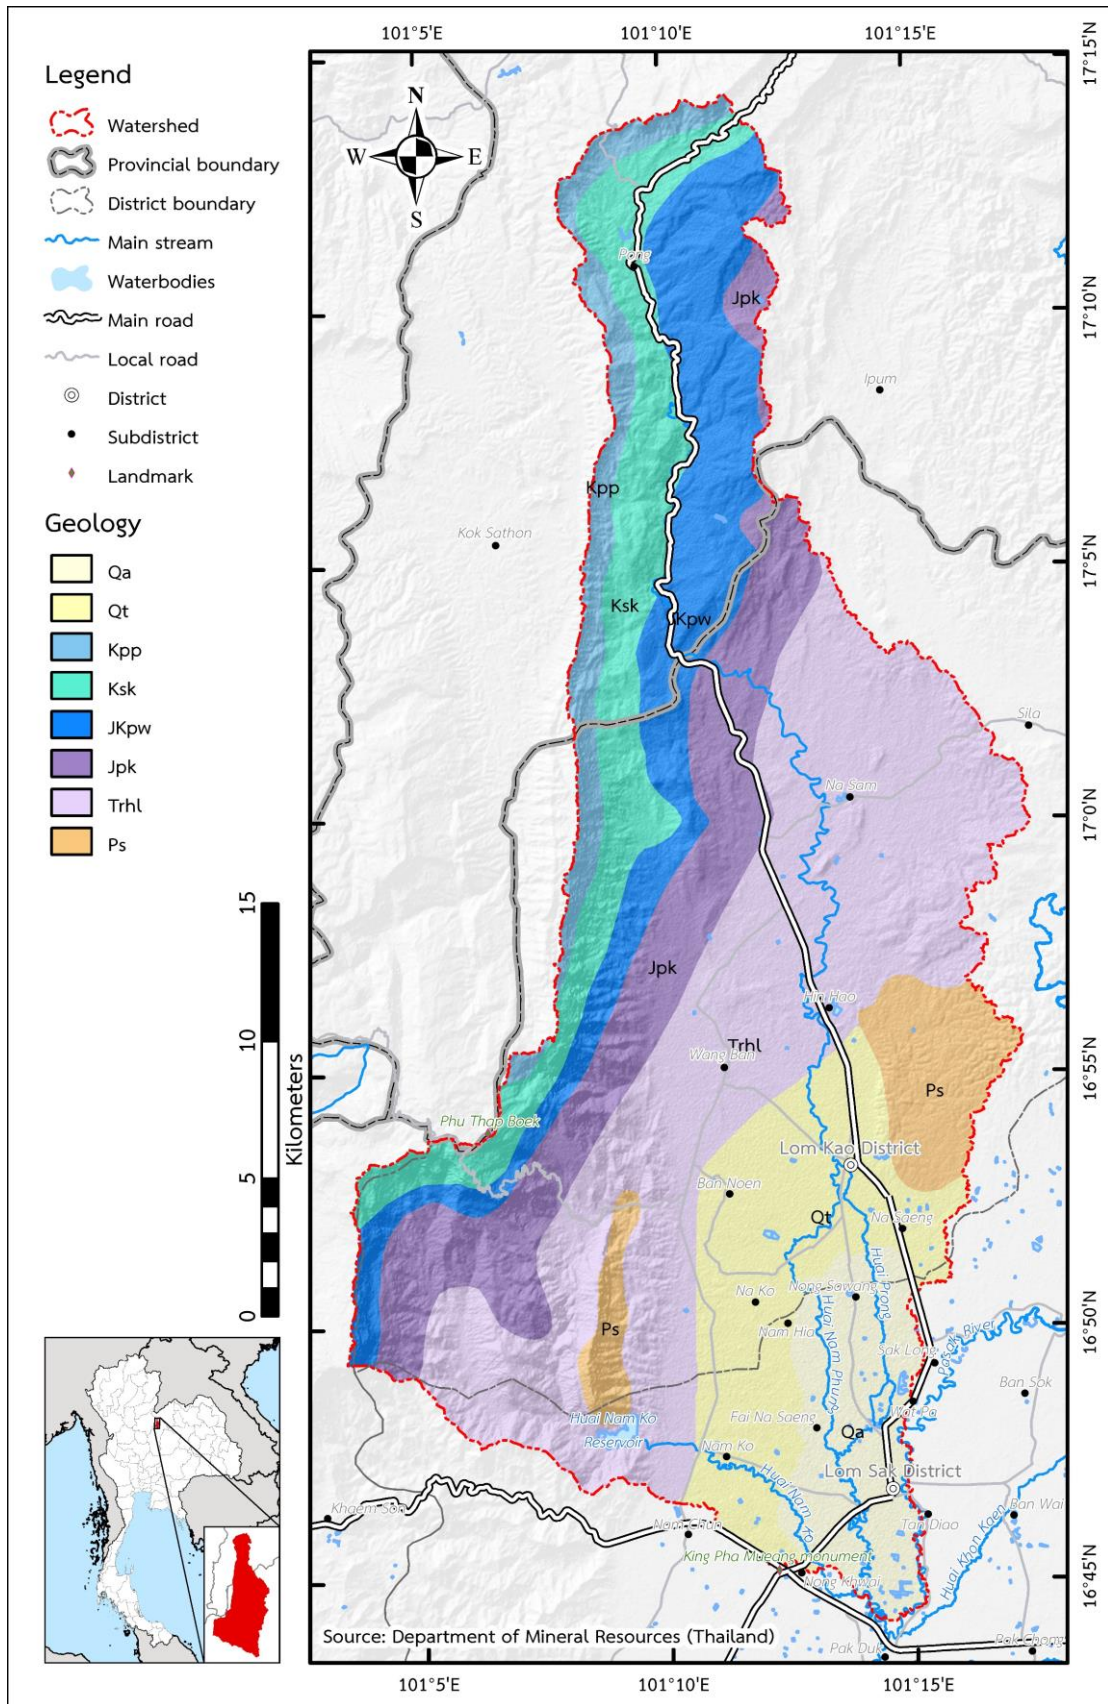
**Figure 3.10** Geological map of the Huai Nam Phung subbasin

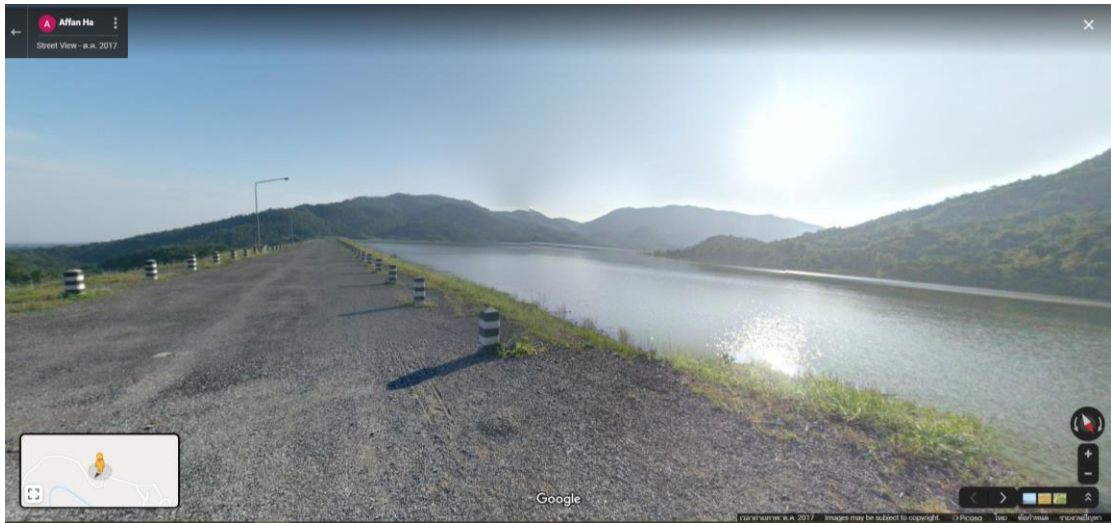
**Figure 3.14** Huai Nam Ko reservoir (Google, 2017)

**Huai Nam Ko reservoir** is a soil dam. The ridge of the dam is located at the longitude of 101° 09' 19" E and the latitude of 16° 48' 00" N, in the area of Nam Ko subdistrict, Lom Sak district, Phetchabun province. This reservoir covers an area of approximately 70 square kilometers (**Figure 3.14**).

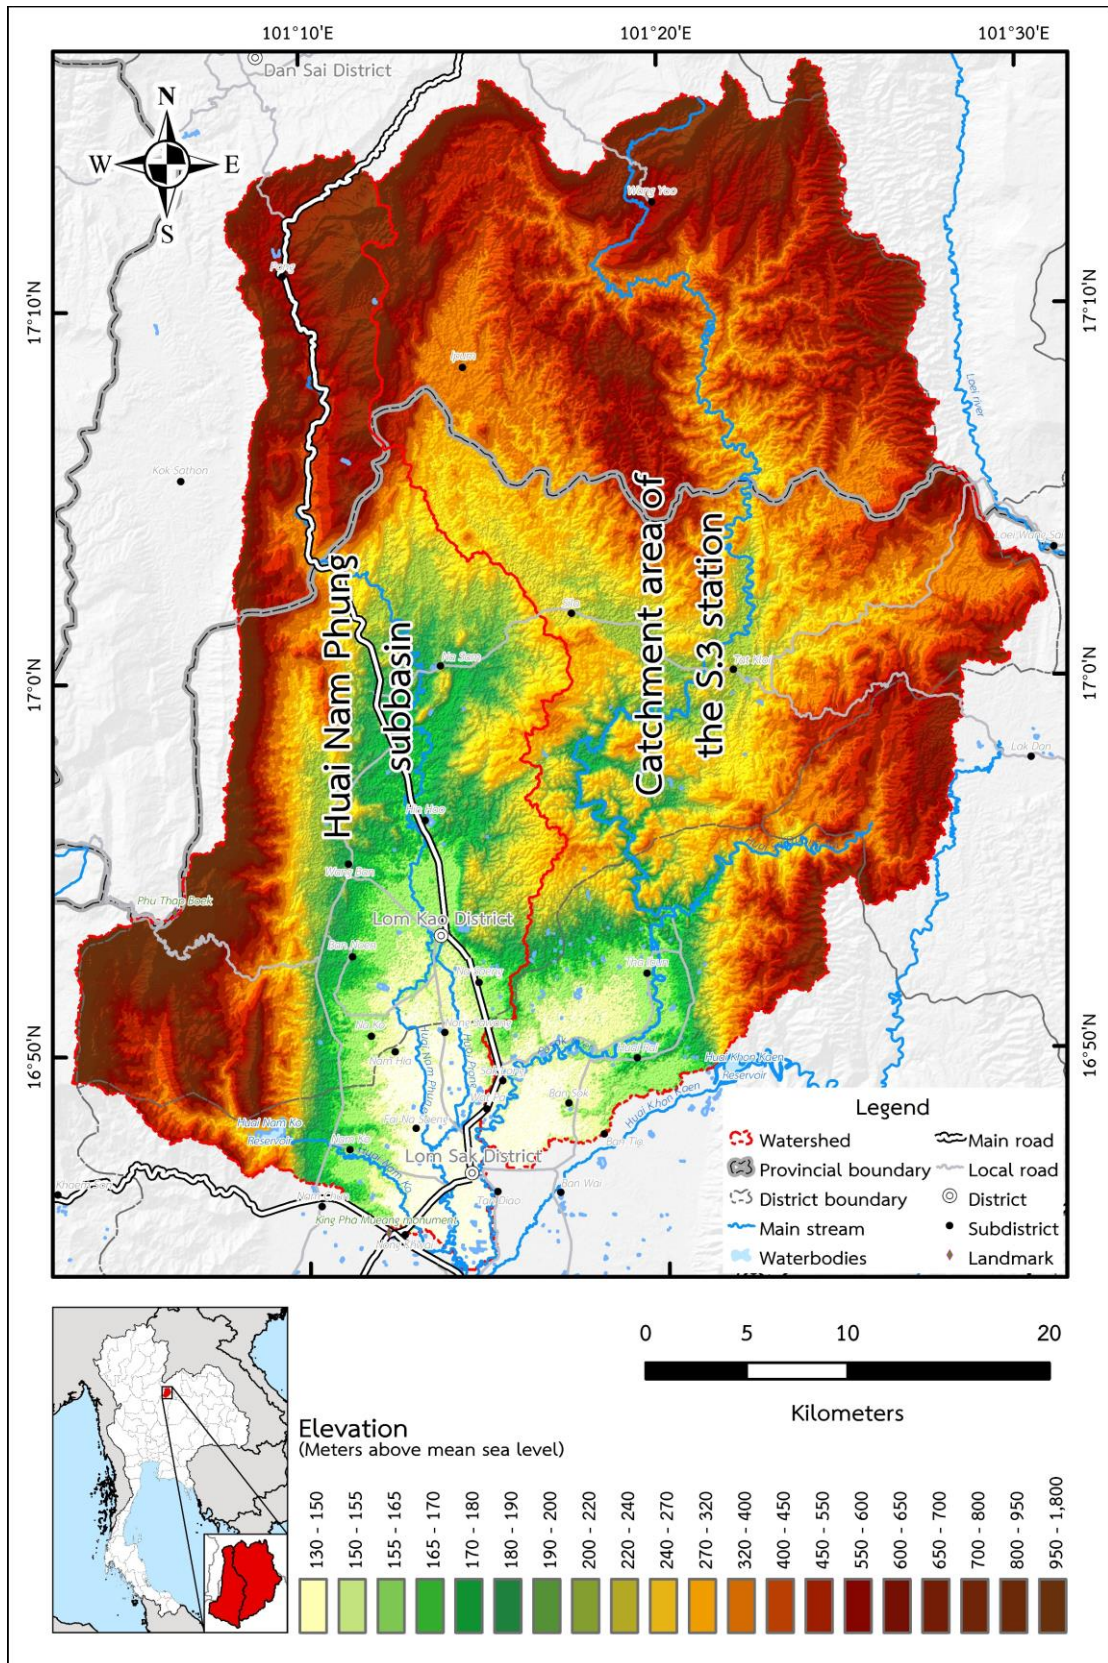
**Figure 3.16** Topographic map of the Huai Nam Phung subbasin and catchment area of the S.3 station

S.3 station is a streamflow measurement station of the Royal Irrigation Department that is located in the Pasak river. The catchment area of the S.3 station is next to the Huai Nam Phung subbasin in the eastern side. It is slightly larger than the Huai Nam Phung subbasin. The terrains of the Huai Nam Phung subbasin and the catchment area of the S.3 station is similar (**Figure 3.16**). With this reason, the observed streamflow data from the S.3 station was used to estimate the streamflow data of the Huai Nam Phung subbasin.

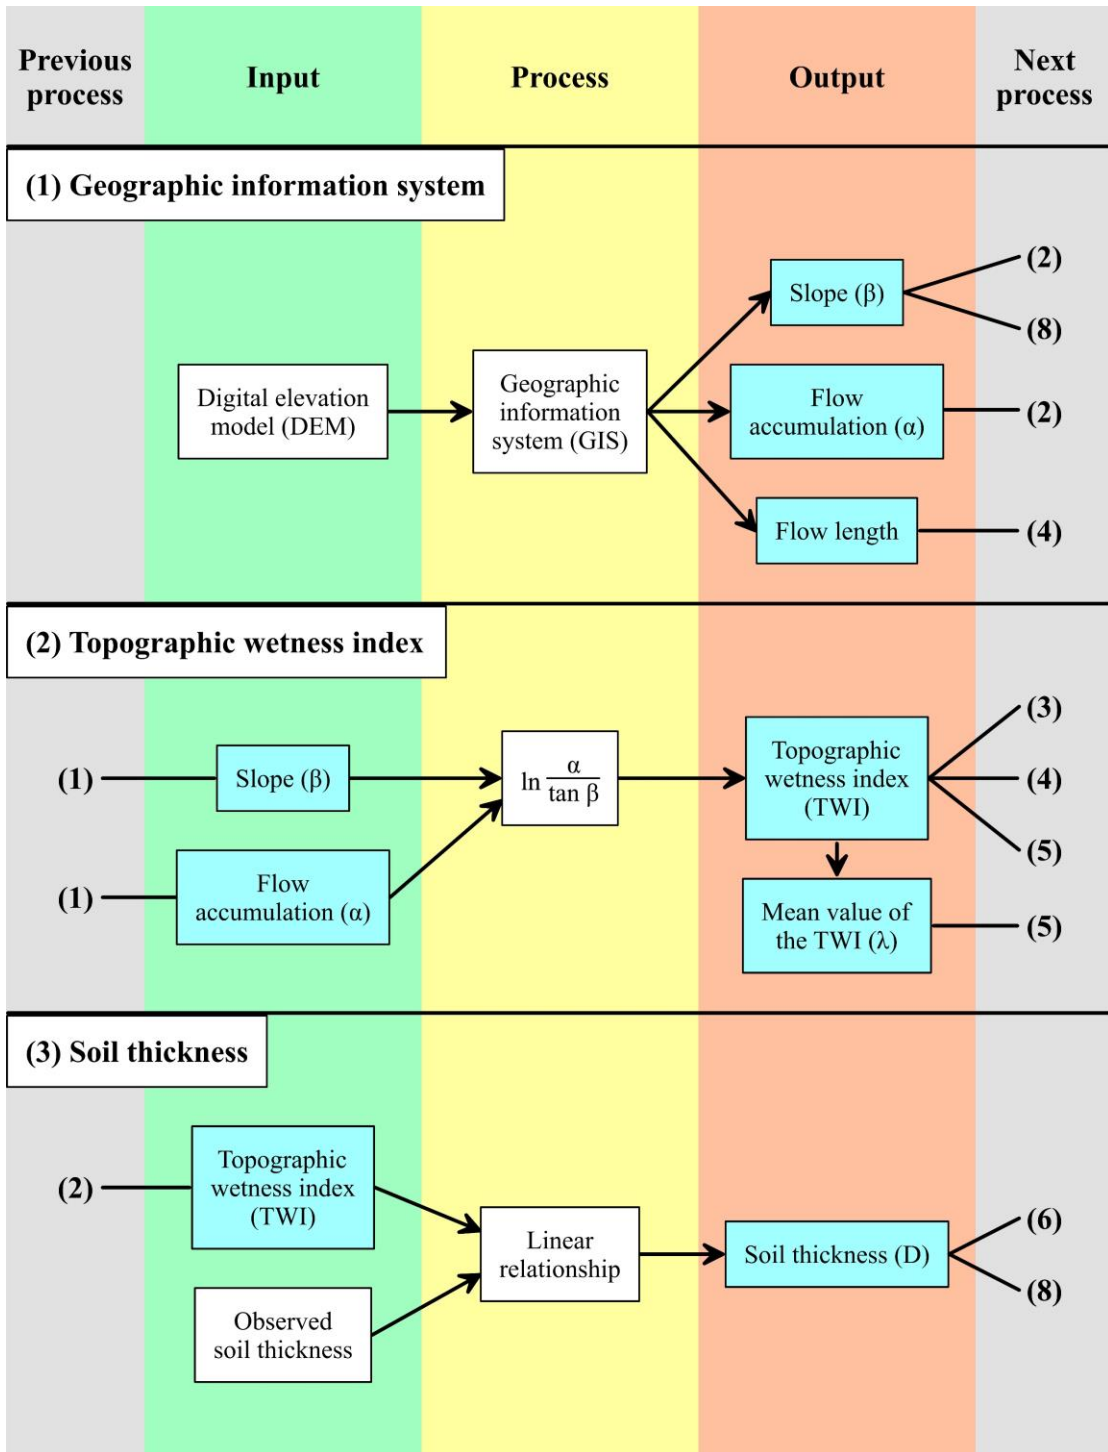
Figure 3.17 Flowchart of research procedure (page 1 of 3)

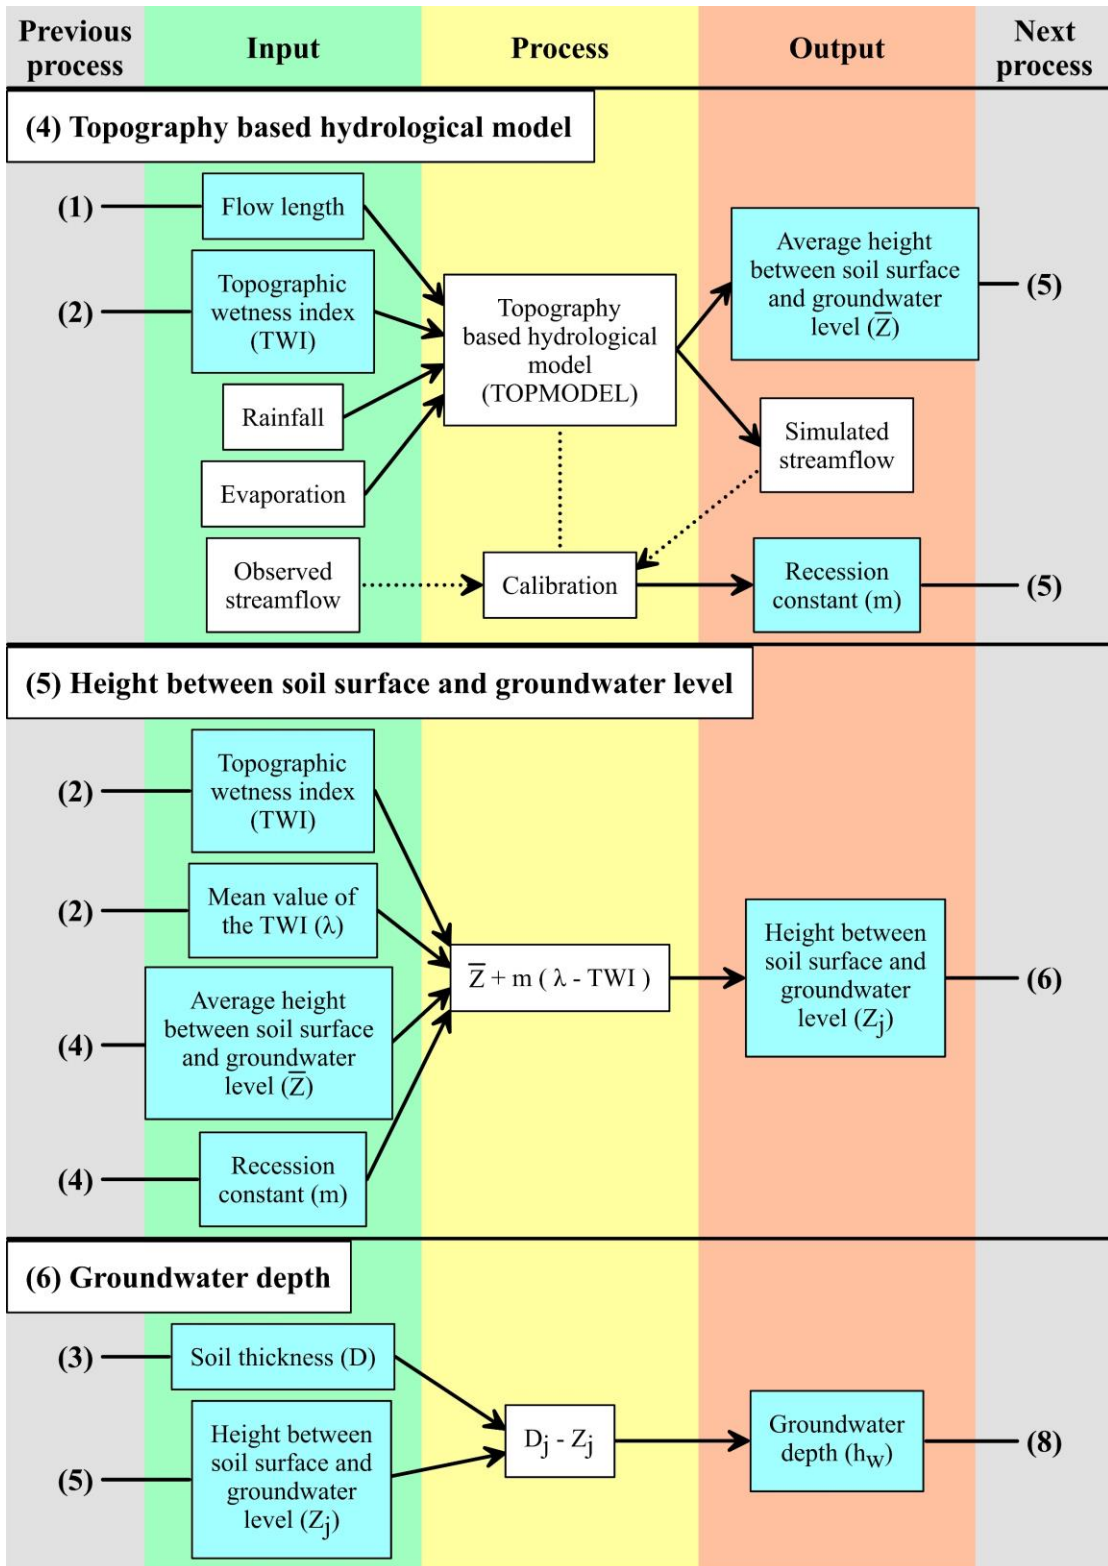
Figure 3.18 Flowchart of research procedure (page 2 of 3)

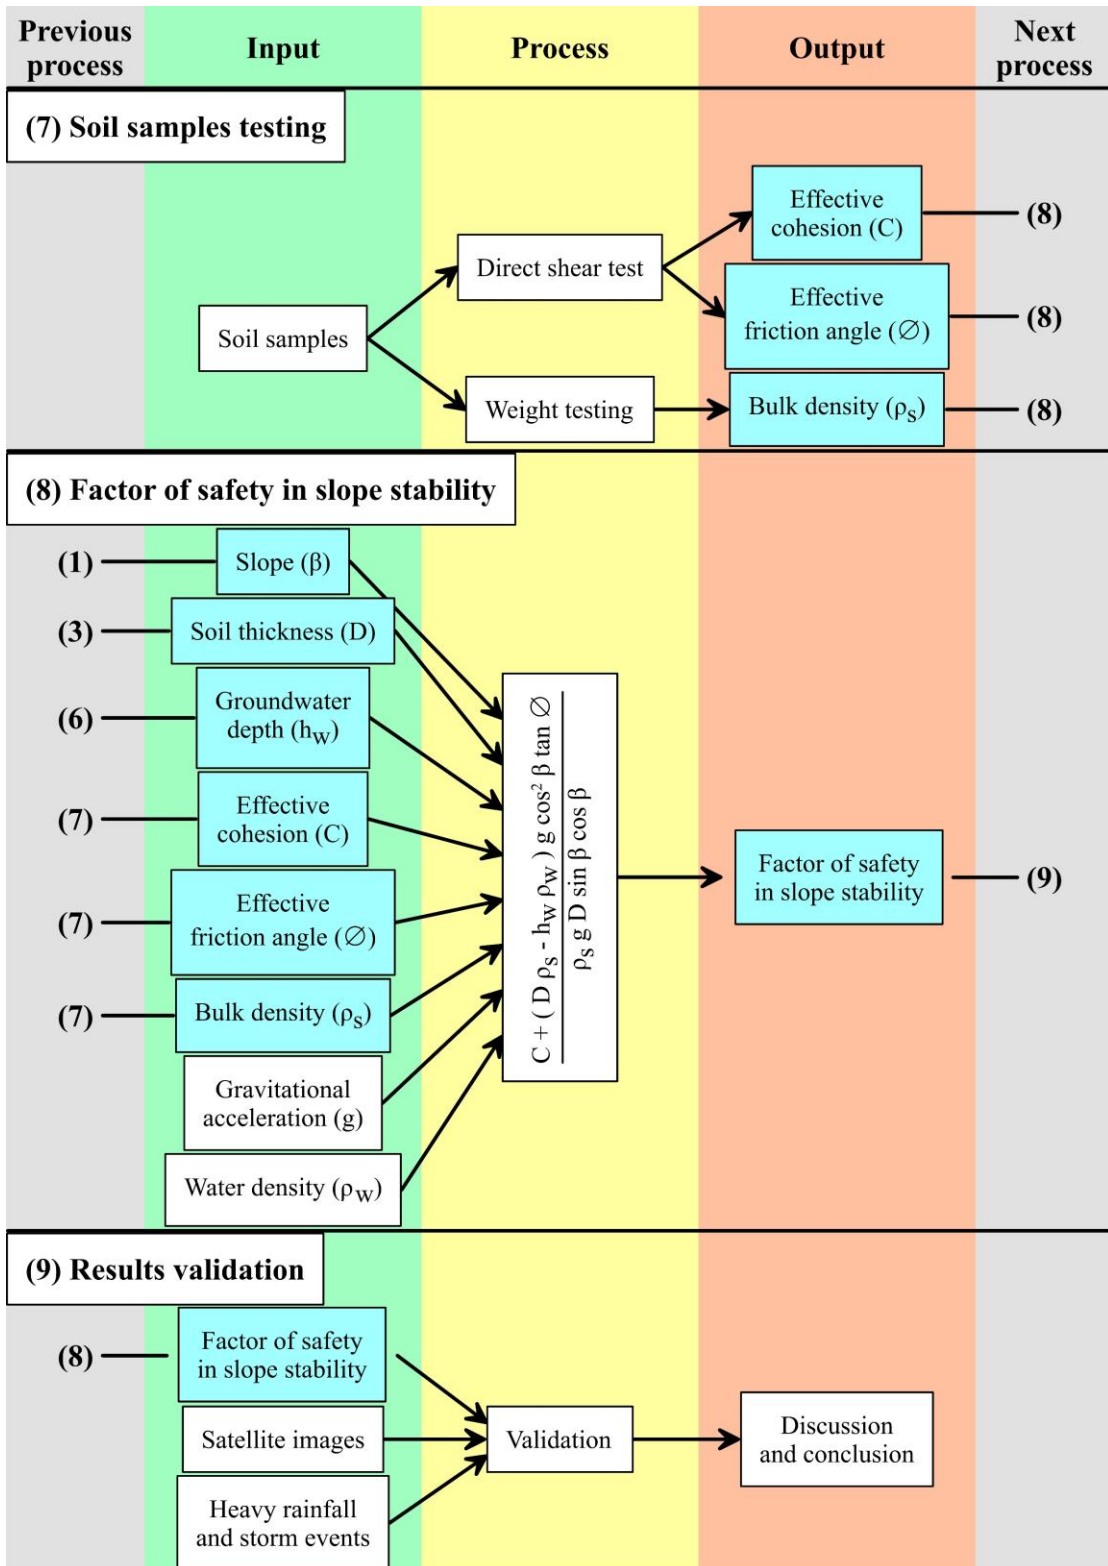
**Figure 3.19** Flowchart of research procedure (page 3 of 3)

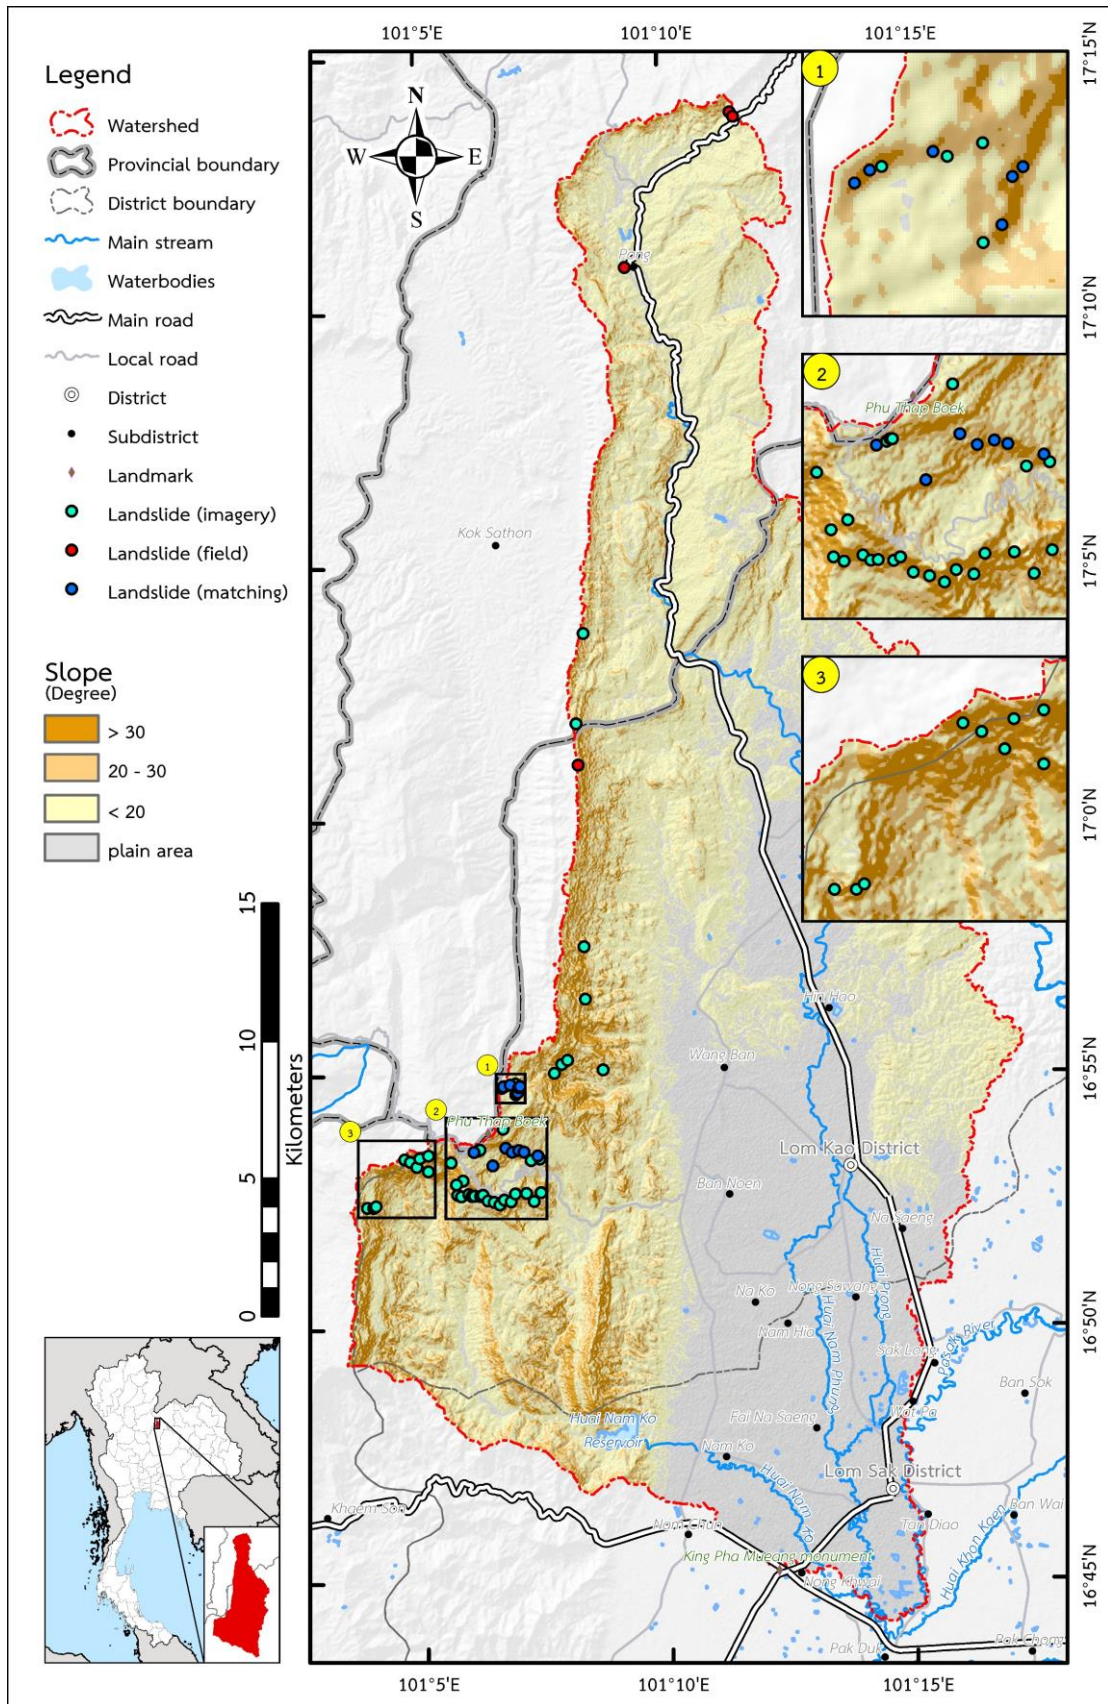
**Figure 4.2** Landslides occurrence in the Huai Nam Phung subbasin in 2017

Most of the landslides that occurred in the Huai Nam Phung subbasin were in the southwestern part of the subbasin. There are 2 big catchments in this area consisting of the Huai Nam Ko catchment and the Huai Nam Hia catchment. In these 2 catchments, occurrences of landslides have been found at 51 points or more. For the Huai Nam Ko catchment, the area is difficult to access because there is a reservoir in the area. Therefore, the landslide occurrences in Huai Nam Ko catchment have still not been confirmed in this field survey (**Figure 4.2**).

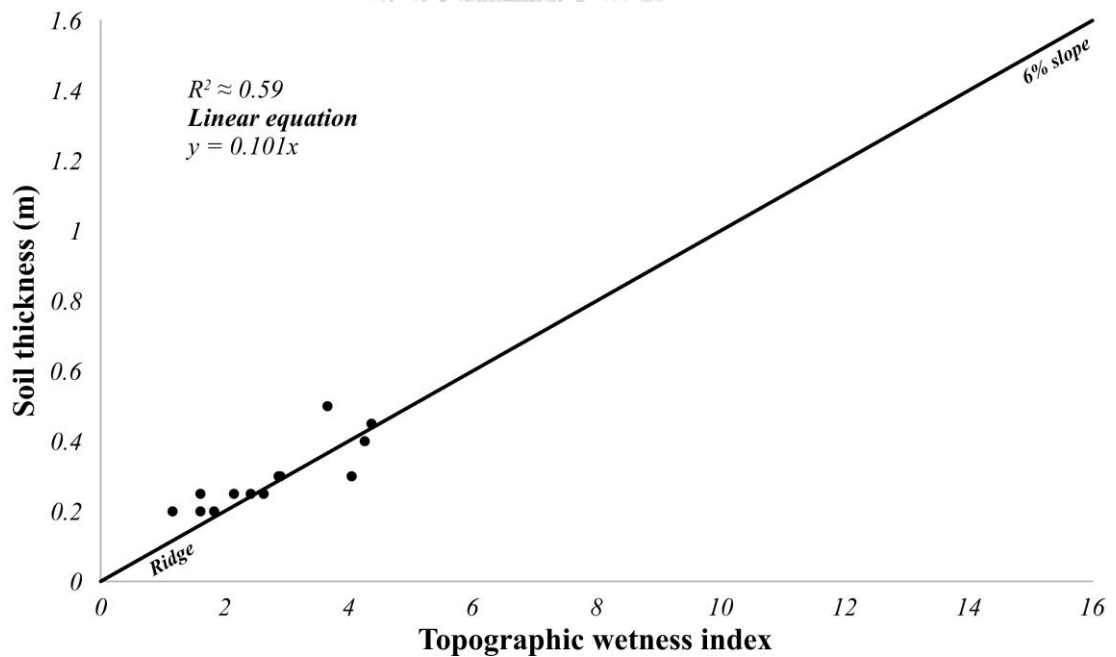
**Figure 4.7** Linear relationship between soil thickness and the topographic wetness index in the Huai Nam Phung subbasin with the slope of higher than 6%

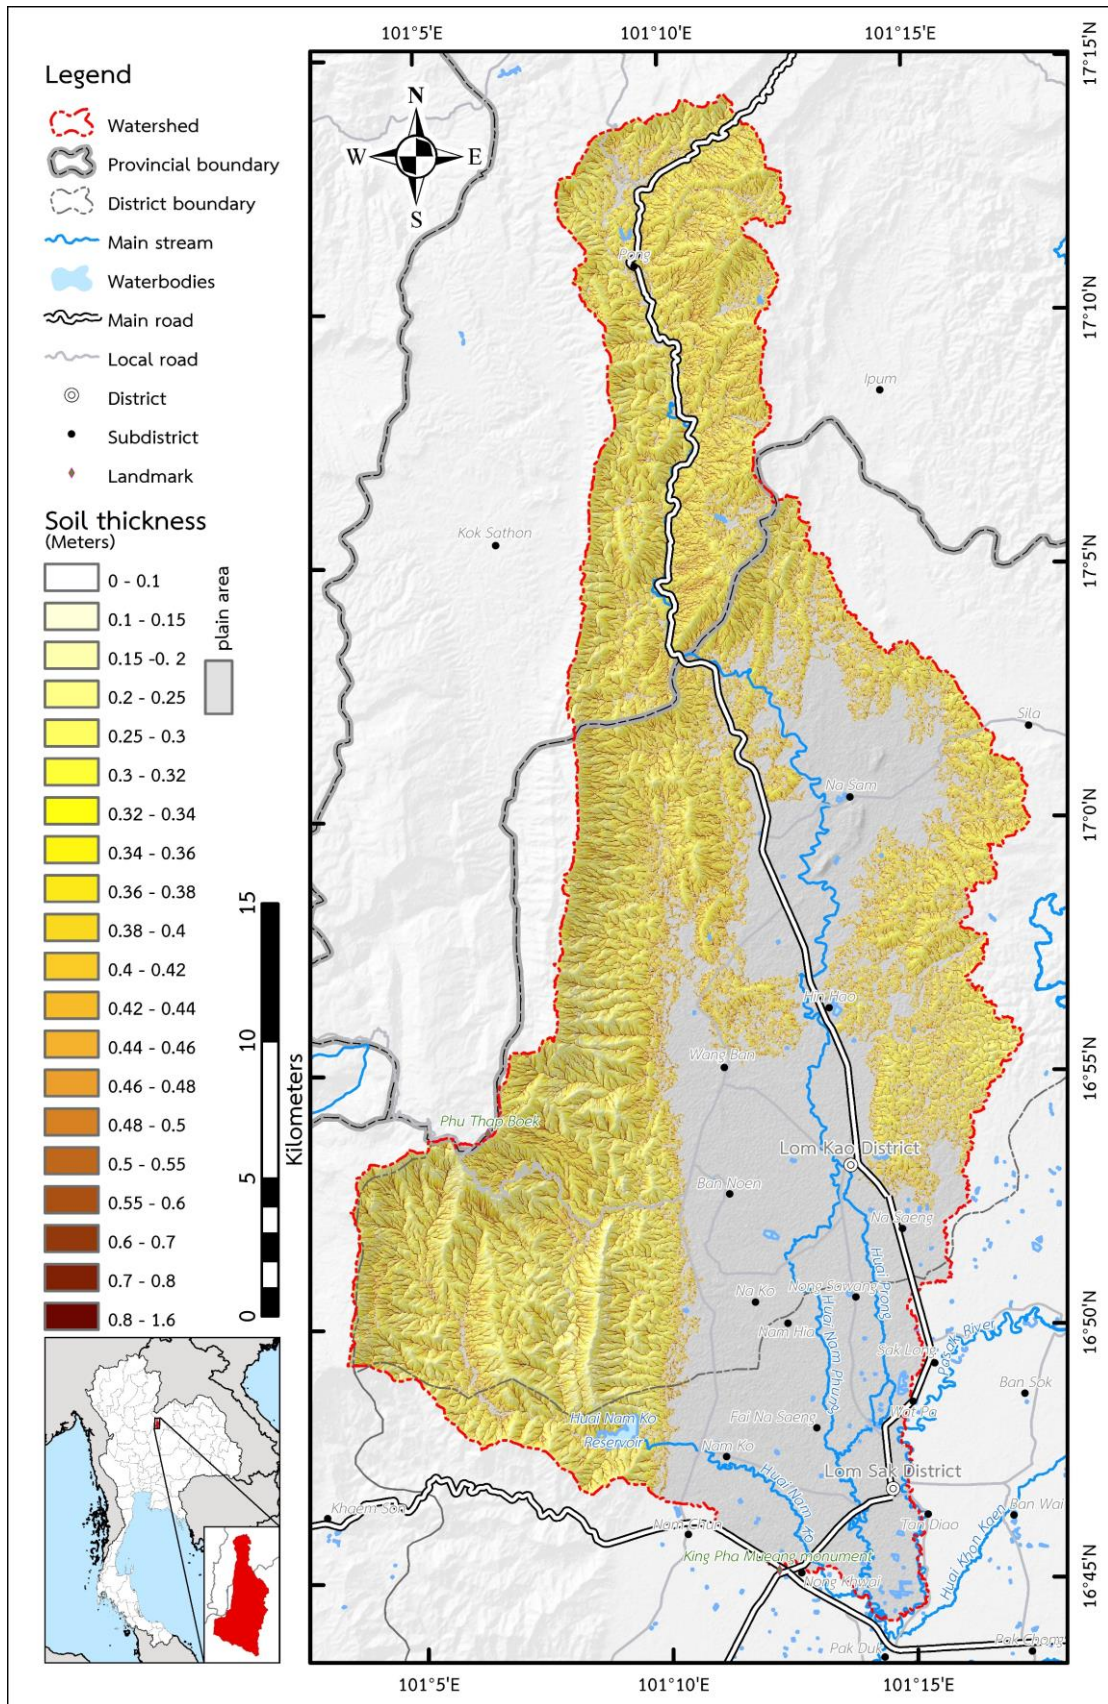
Figure 4.8 Soil thickness of the Huai Nam Phung subbasin

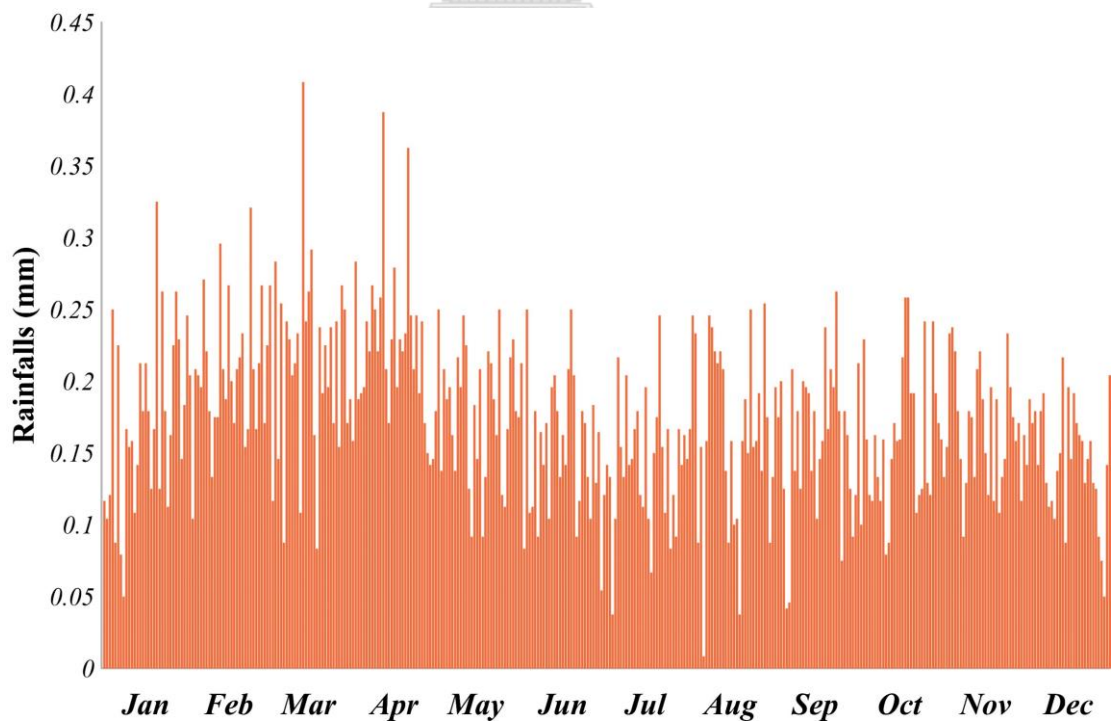
**Figure 4.13** Daily evaporation in the Huai Nam Phung subbasin in 2017

This study used the evaporation data collected by TMD using the American class A pan. There was only one evaporation station (379401) where is located in Lom Sak district, Phetchabun province. In 2016, the average evaporation rate was 0.18 mm per day (**Figure 4.12**). In 2017, the average evaporation rate was 0.17 mm per day (**Figure 4.13**).

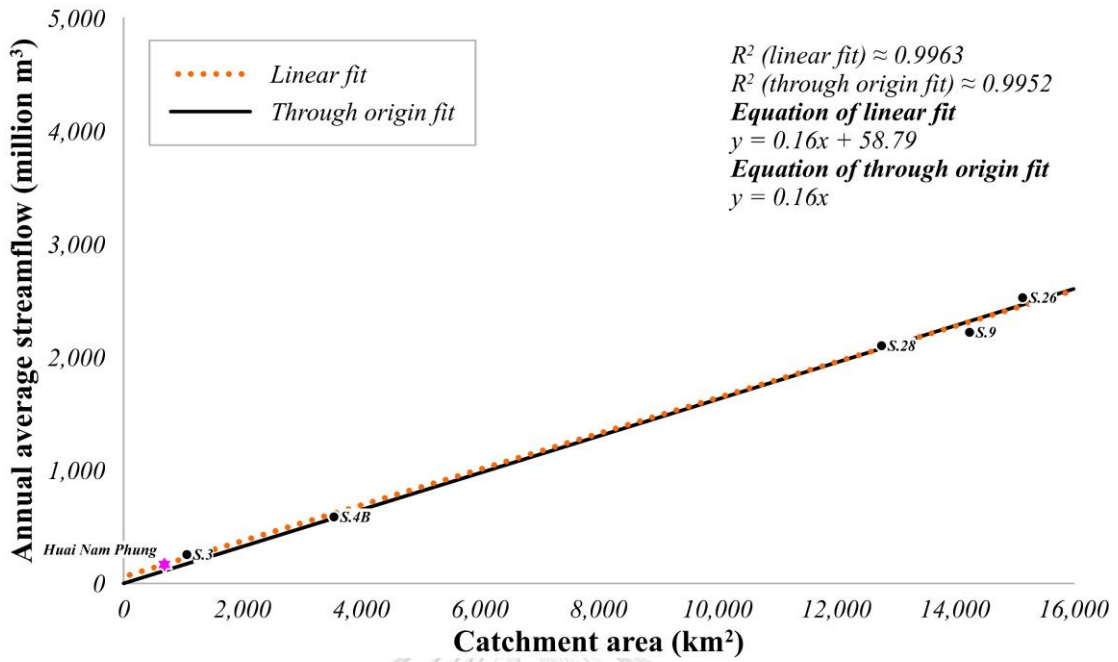
**Figure 4.14** Relationship between annual average streamflow and catchment area in the Pasak river basin in 2016

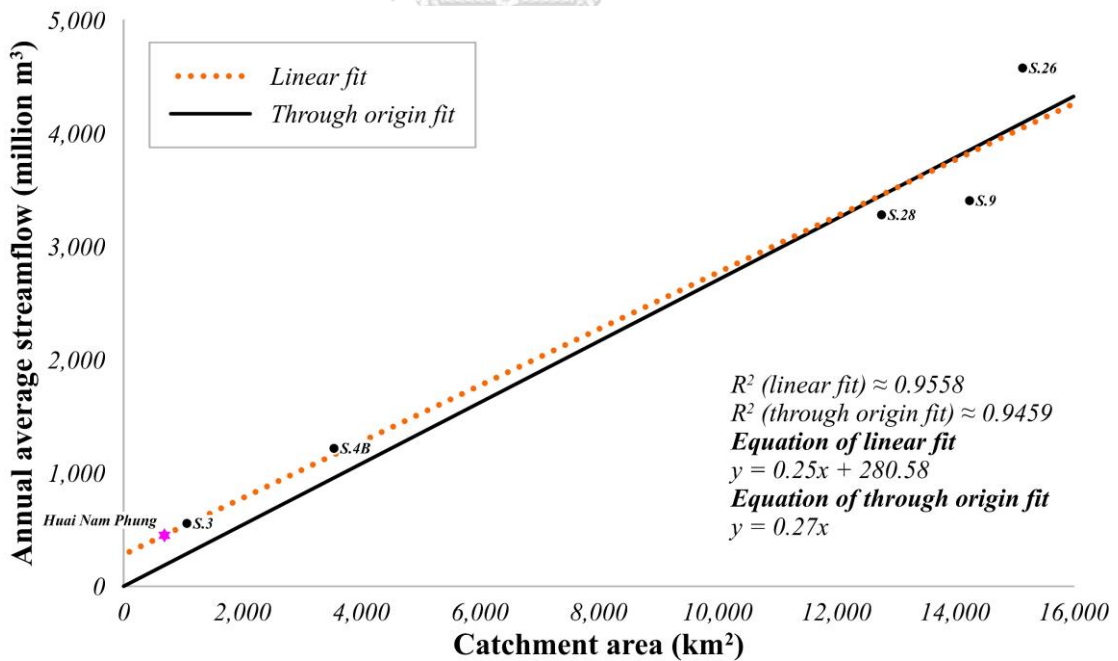
**Figure 4.15** Relationship between annual average streamflow and catchment area in the Pasak river basin in 2017

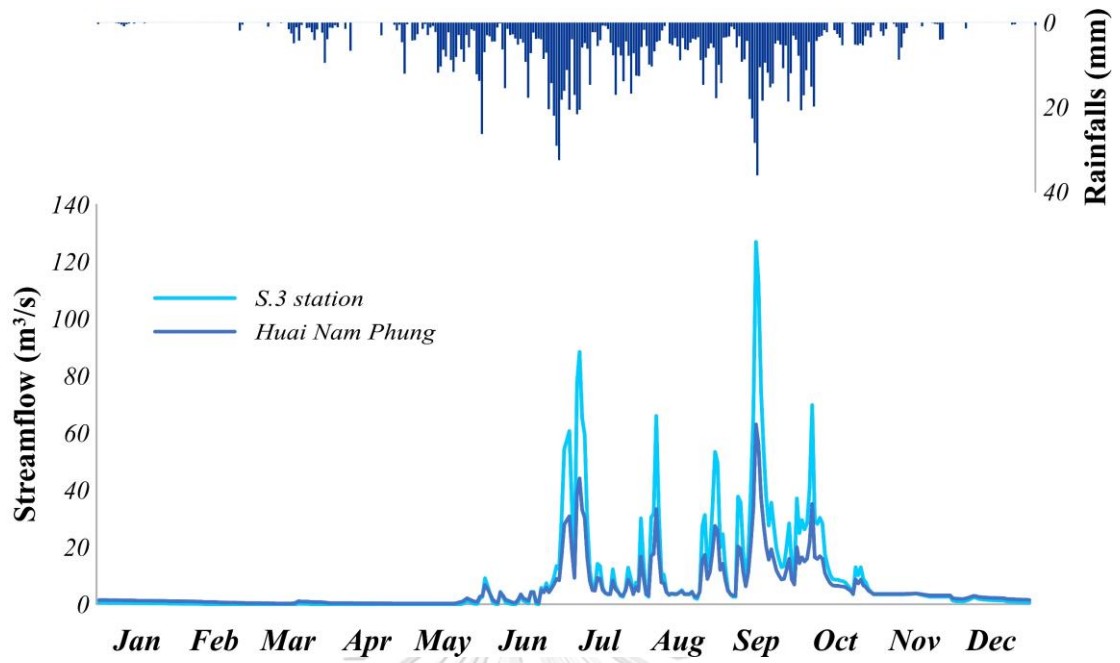
**Figure 4.16** Comparison between the observed streamflow at the S.3 station and the calculated streamflow of the Huai Nam Phung subbasin in 2016
