EVALUATION OF LANDSLIDE OCCURRENCE USING  
HYDROLOGICAL MODEL IN HUAI NAM PHUNG  
SUBBASIN, THAILAND

A Thesis Submitted in Partial Fulfillment of the Requirements  
for the Degree of Master of Science in Earth Sciences  
Department of Geology  
FACULTY OF SCIENCE  
Chulalongkorn University  
Academic Year 2019  
Copyright of Chulalongkorn University

Thesis Title                                   EVALUATION OF LANDSLIDE OCCURRENCE USING  
HYDROLOGICAL MODEL IN HUAI NAM PHUNG  
SUBBASIN, THAILAND  
By   Acting SubLt. Rugkiet Chansorn  
Field of Study                                 Earth Sciences  
Thesis Advisor                               Associate Professor SRILERT CHOTPANTARAT, Ph.D.  
Thesis Co Advisor                         Pawee Klongvessa, Eng.D.

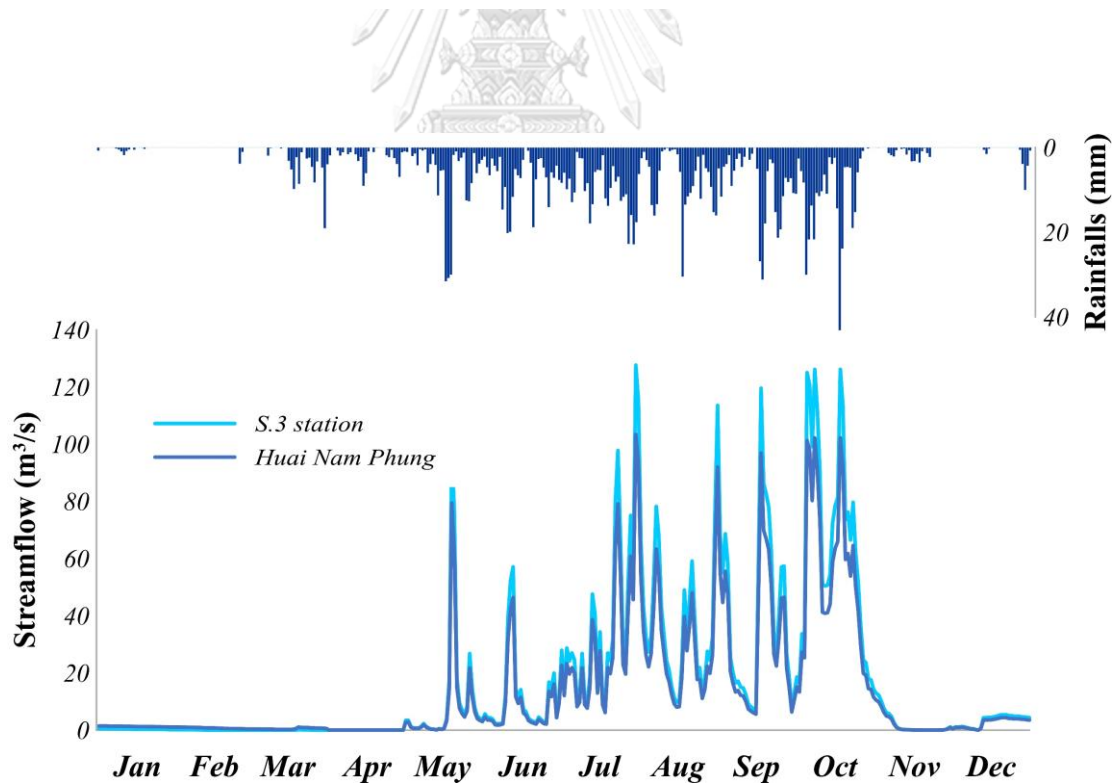
**Figure 4.17** Comparison between the observed streamflow at the S.3 station and the calculated streamflow of the Huai Nam Phung subbasin in 2017

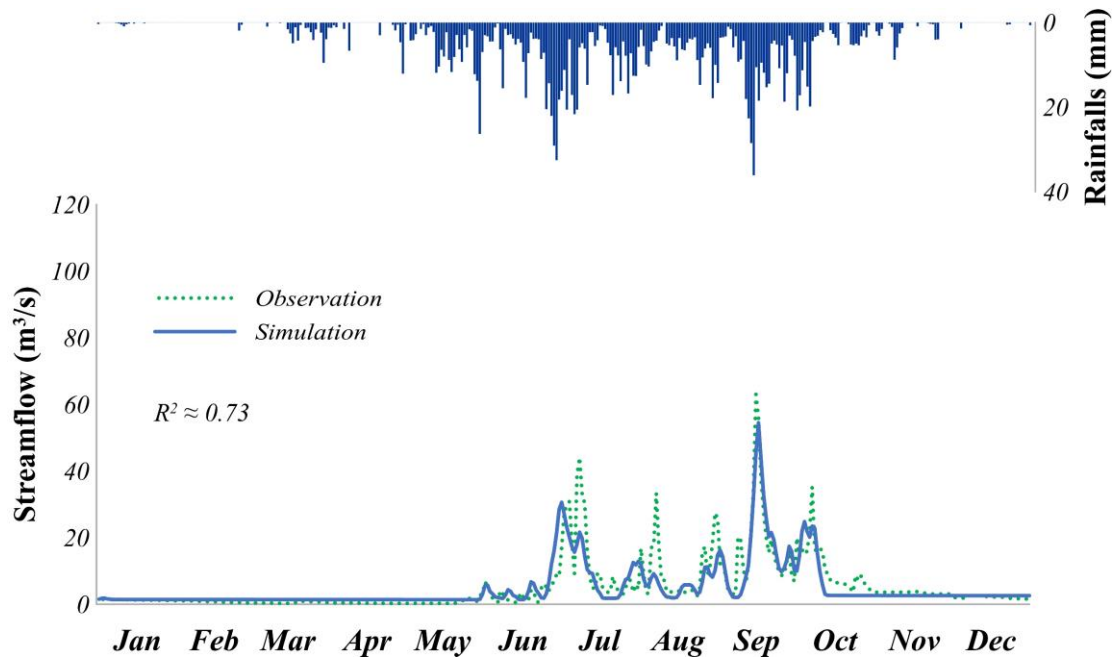
**Figure 4.18** Comparison between the observed streamflow and the simulated streamflow in the Huai Nam Phung subbasin in 2016

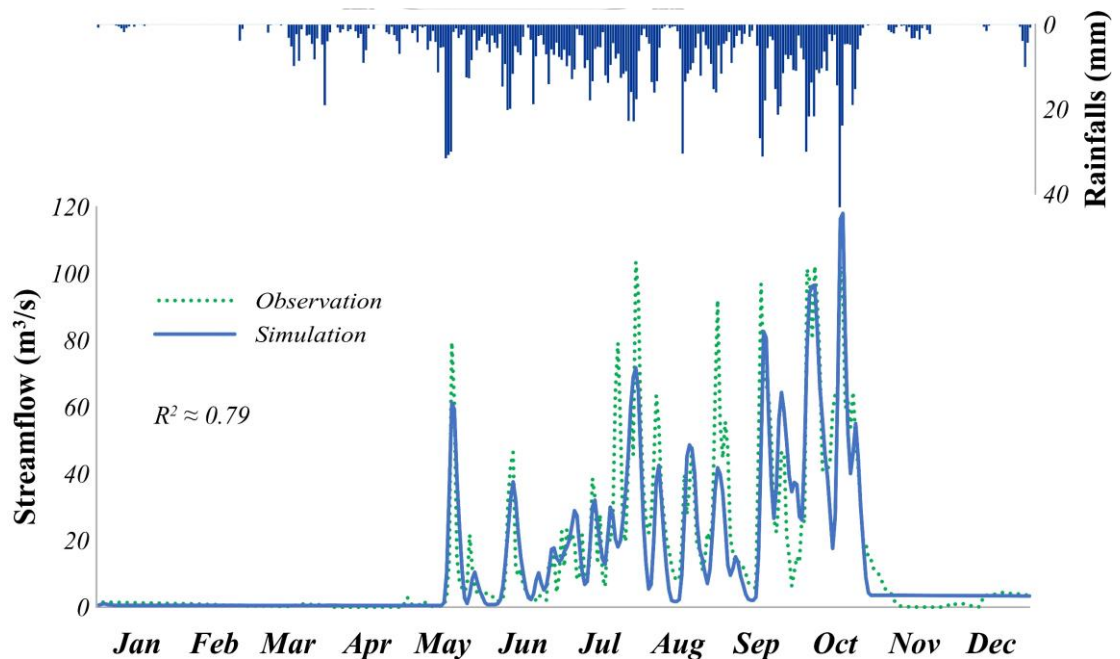
**Figure 4.19** Comparison between the observed streamflow and the simulated streamflow in the Huai Nam Phung subbasin in 2017

The simulation of the Huai Nam Phung subbasin was done by its own physical data. The observed streamflow calculated from the data at the station S.3 was used to calibrate the unknown parameters. The streamflow hydrograph simulated from the topography based hydrological model (TOPMODEL) shows that the discharge is associated with the rainfall data. The values of  $R^2$  in 2016 and 2017 are 0.73 and 0.79, respectively. The simulation results suggest that the streamflow in 2016 had the highest value of is 54.50 m<sup>3</sup>/s on 16 September, 2016 (**Figure 4.18**) and the streamflow in 2017 had the highest value of 118.05 m<sup>3</sup>/s on 19 October, 2017 (**Figure 4.19**).

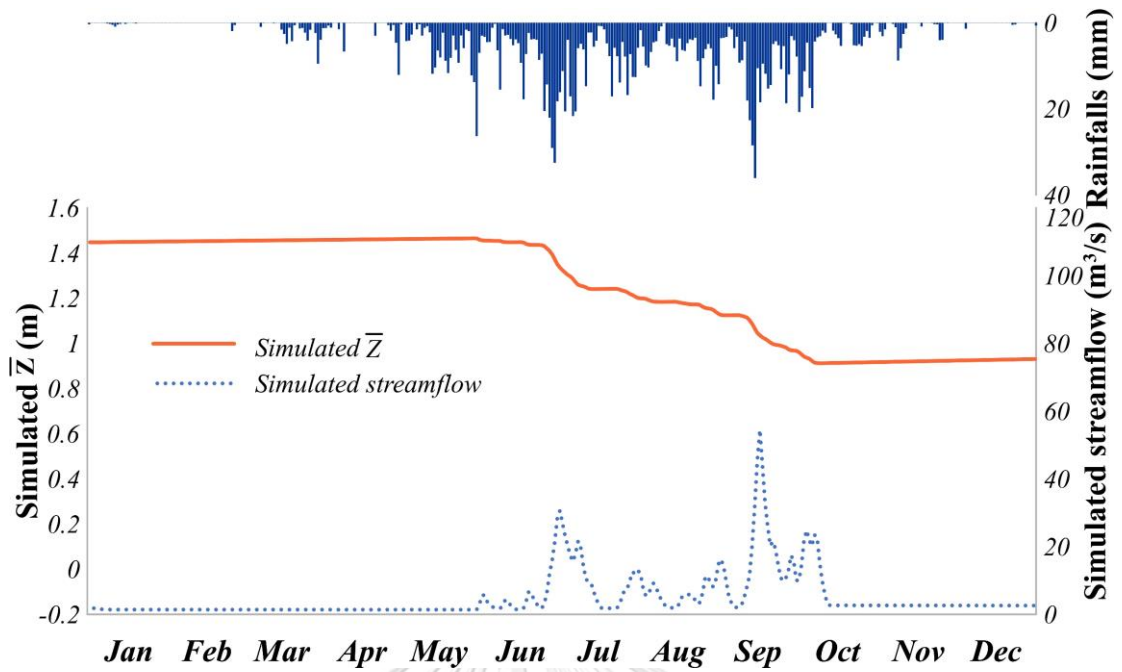
**Figure 4.20** The simulated average height ( $\bar{Z}$ ) between soil surface and groundwater level in the Huai Nam Phung subbasin in 2016

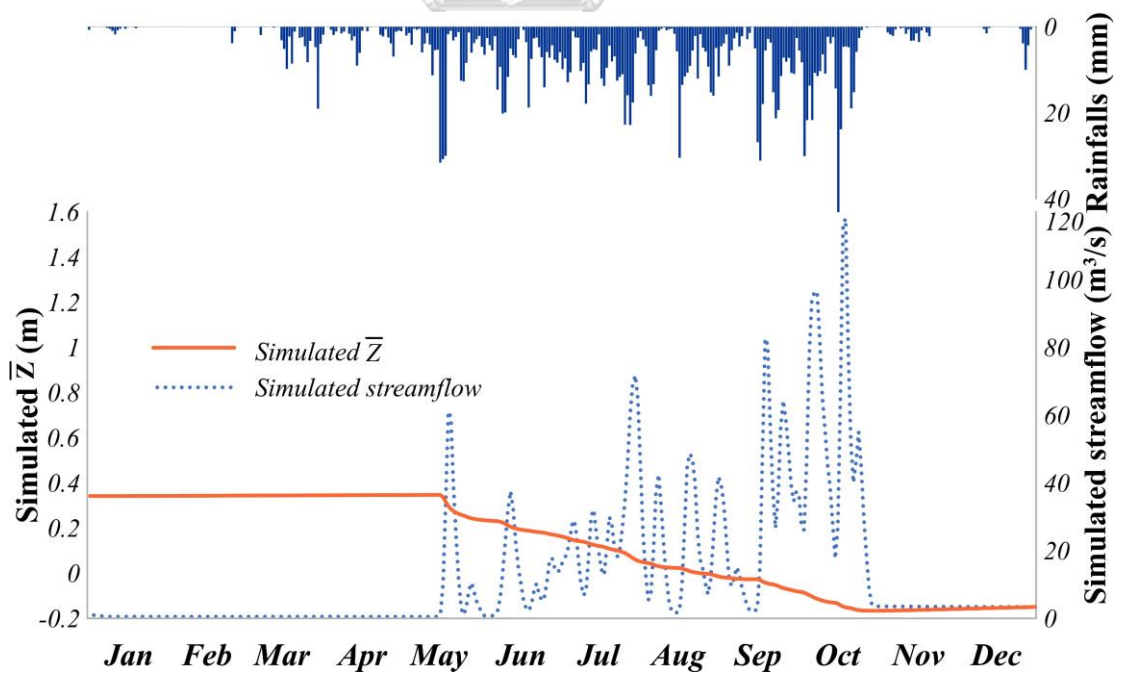
**Figure 4.21** The simulated average height ( $\bar{Z}$ ) between soil surface and groundwater level in the Huai Nam Phung subbasin in 2017

In 2017, both rainfall and runoff were much higher than those in 2016. Therefore, the values of simulated height between soil surface and groundwater level was very low. There were no any locations with the  $Z_j$  value of higher than 2 meters (Figure 4.23). The lowest value appeared on 30 October, 2017. Many parts of the area were found the  $Z_j$  values were lower than 0, indicating that groundwater level was very high and generate the surface runoff.

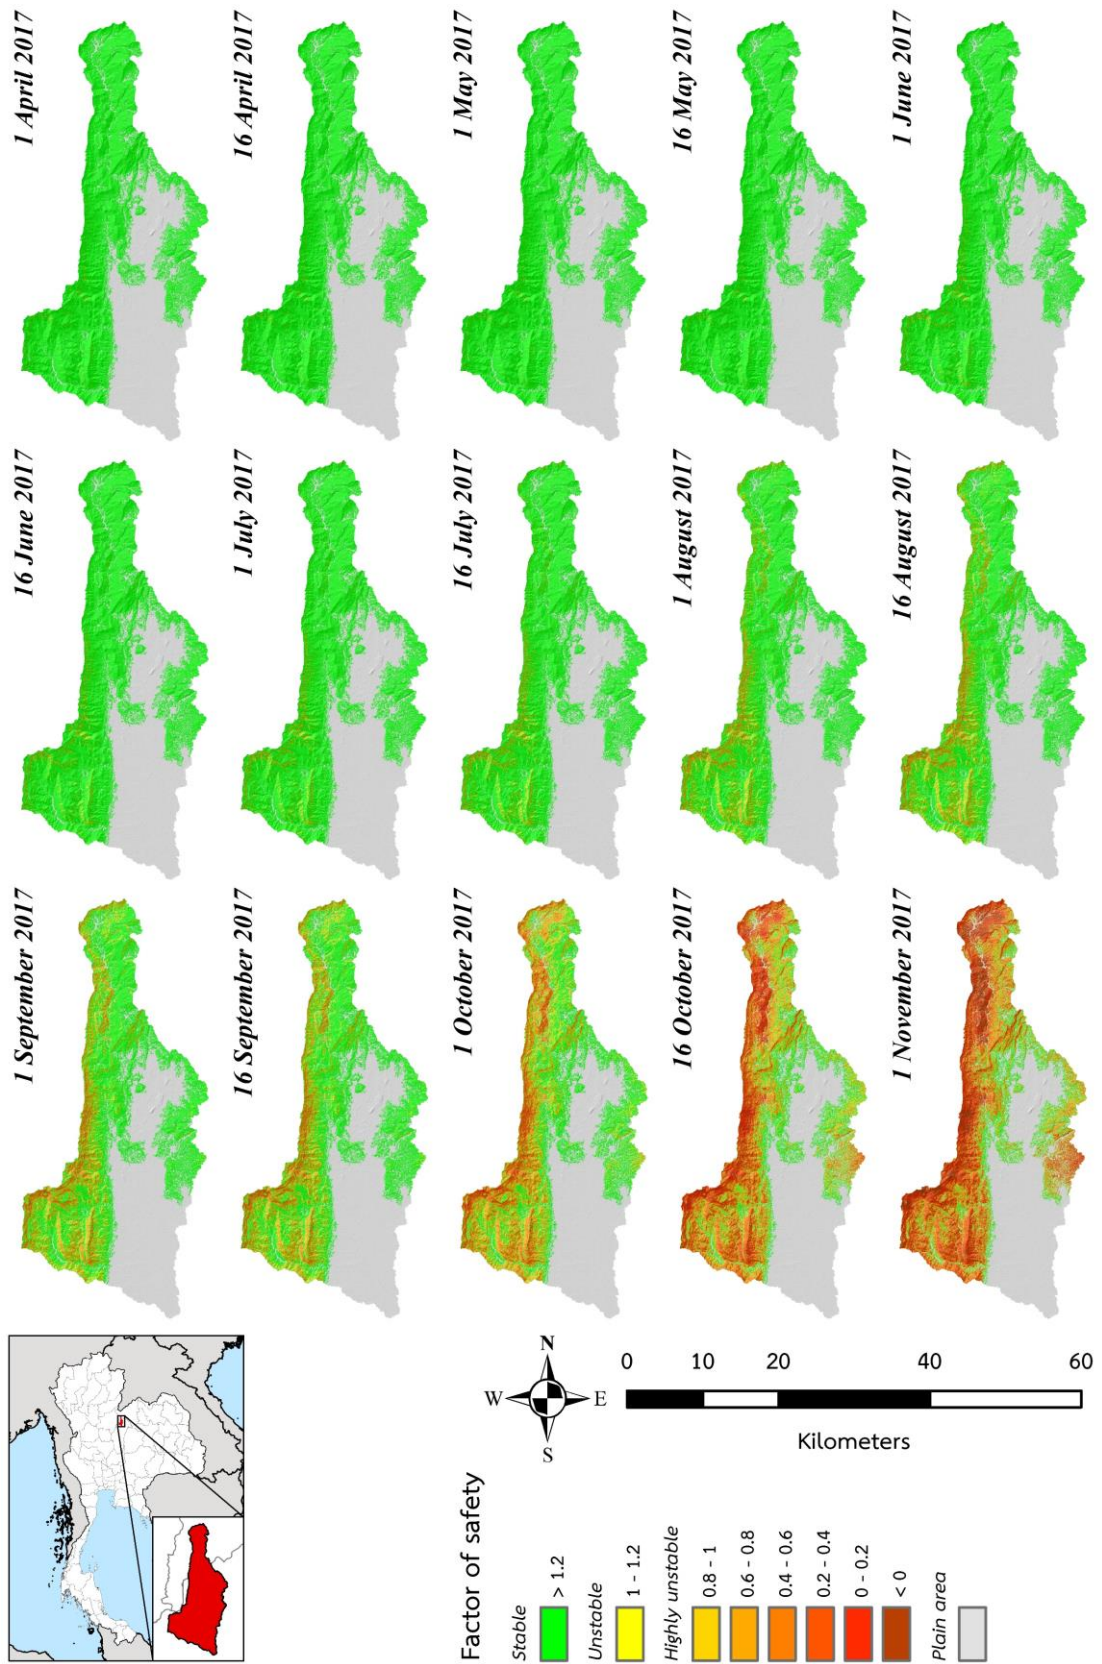
**Figure 4.26** Factor of safety in slope stability of the Huai Nam Phung subbasin from 1 April to 1 November, 2017

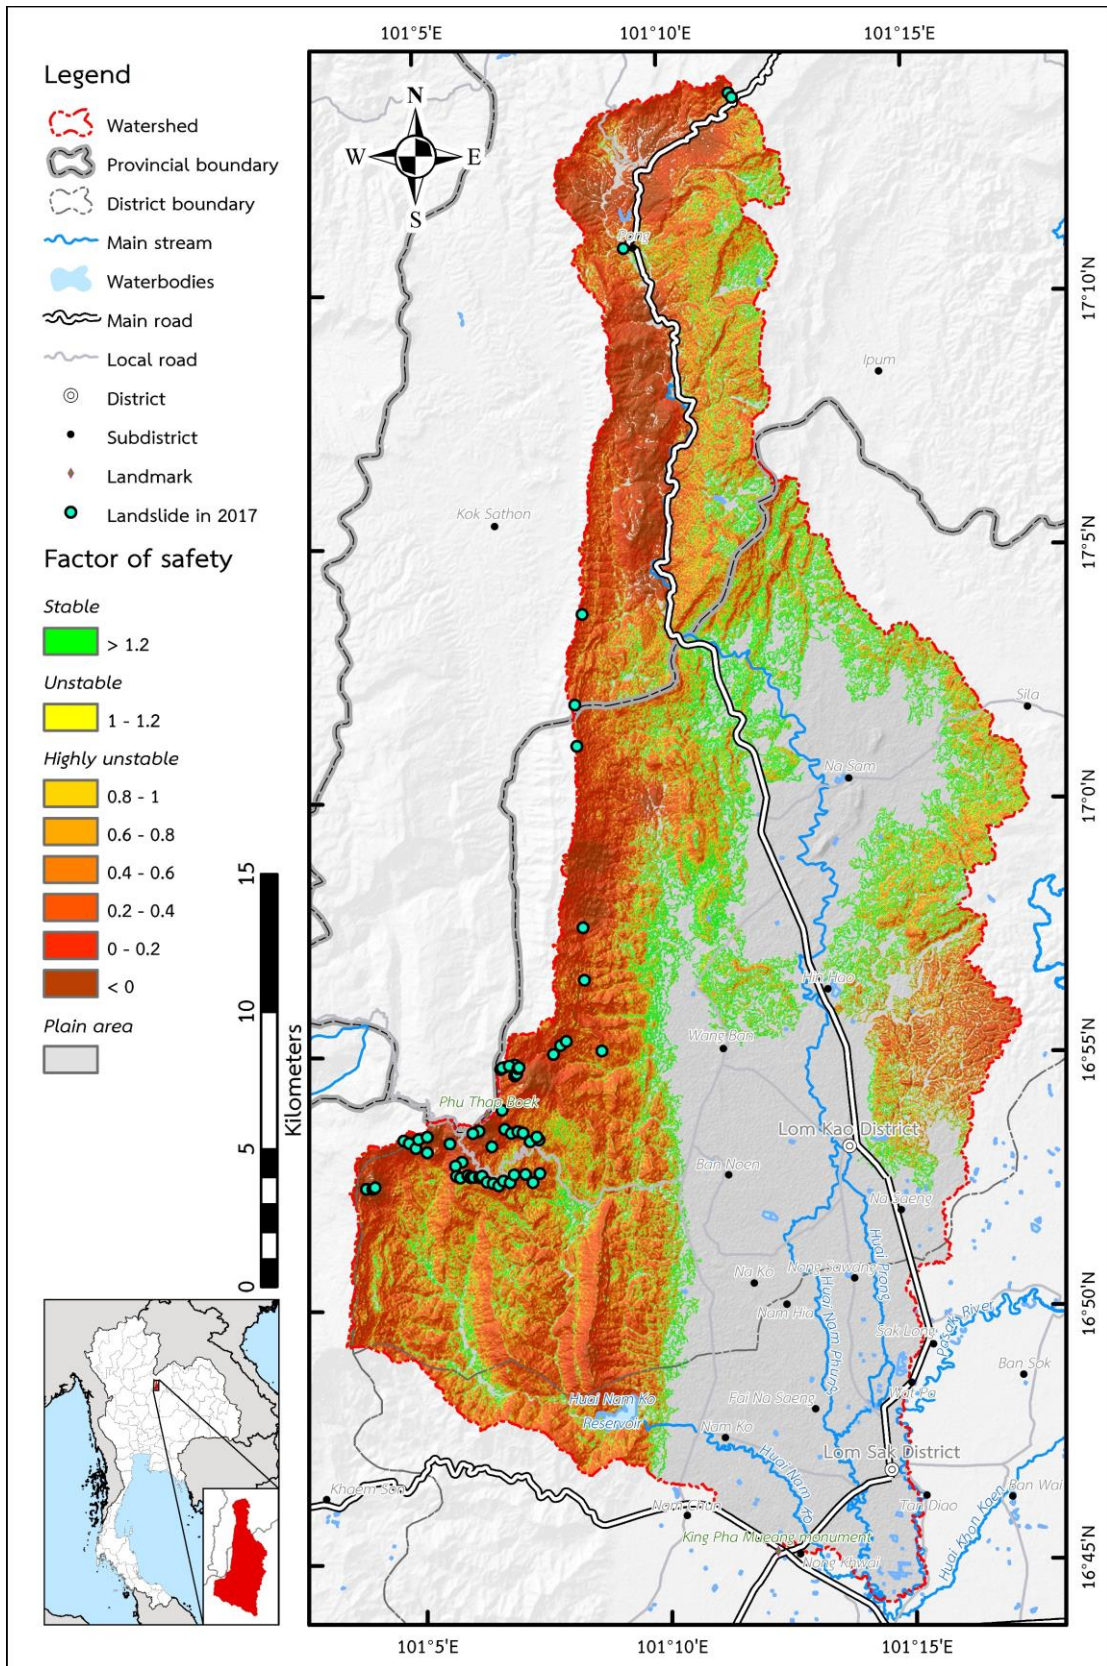
**Figure 4.27** Factor of safety in slope stability of the Huai Nam Phung subbasin on 30 October, 2017

The most unstable grids were found in 30 October, 2017 (**Figure 4.27**). There were 323.76 km<sup>2</sup> of unstable area which was accounting for 47.22% of the total area. Most of the unstable areas are along mountain ranges in the western and northern parts of the basin, especially in the area of Phu Thap Boek and Nam Ko catchment in the southwestern part of basin. On the other hand, the plain areas in the central part of the basin were still stable. All of the areas with a high slope of more than 30 degrees were unstable.

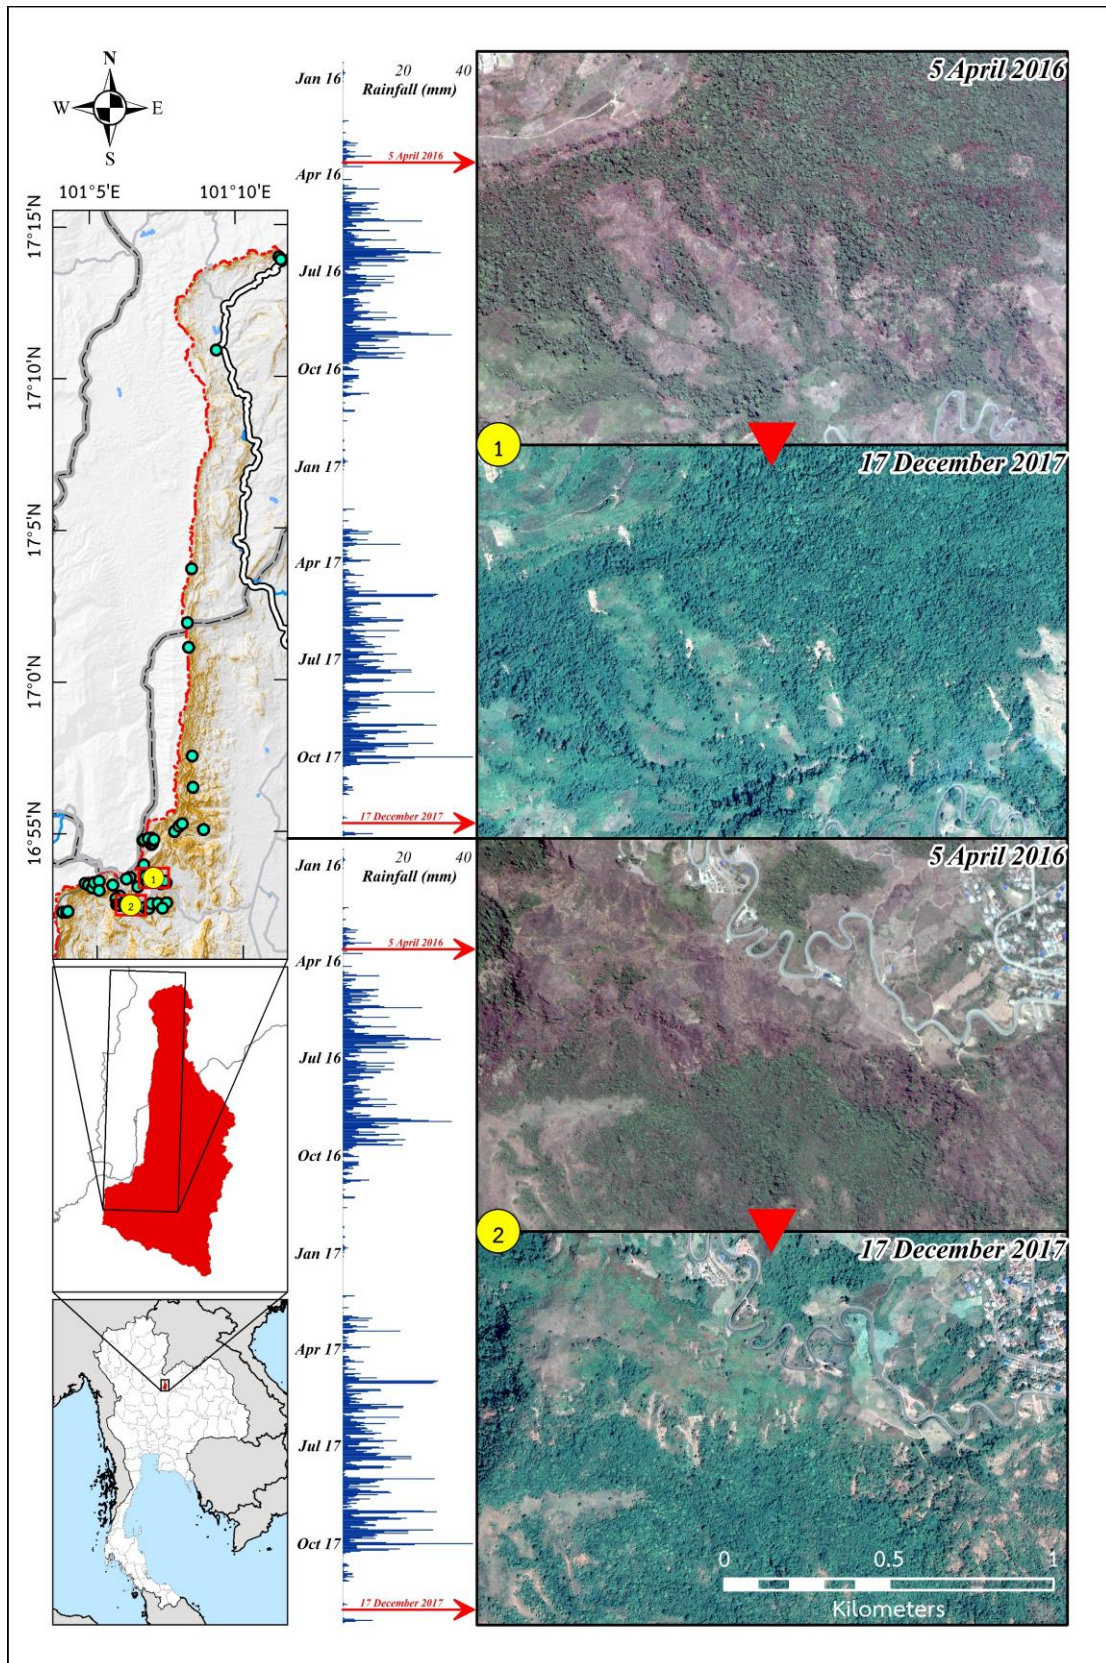
**Figure 5.2** Comparison of satellite imageries in the Huai Nam Phung subbasin between 2016 and 2017 in areas of the Phu Thap Boek

From the data analysis by remote sensing during 2016 and 2017, landslides occurred between 5 April 2016 and 17 December 2017 (**Figure 5.2**). The satellite imagery from Google Earth can investigate backward for some periods. The landslides may occur in the rainy seasons of 2016 or 2017. However, since the landslides often occur due to heavy rainfalls (Casagli et al., 2006; Guthrie and Evans, 2004; Keefer et al., 1987), it can infer that landslides in the Huai Nam Phung subbasin occurred in the rainy seasons of 2017 since the rainfall in 2016 is quite relatively lower than that in 2017. Therefore, landslide surveys would be better if satellite imagery data was with more detailed and the field survey could reach more landslide areas.

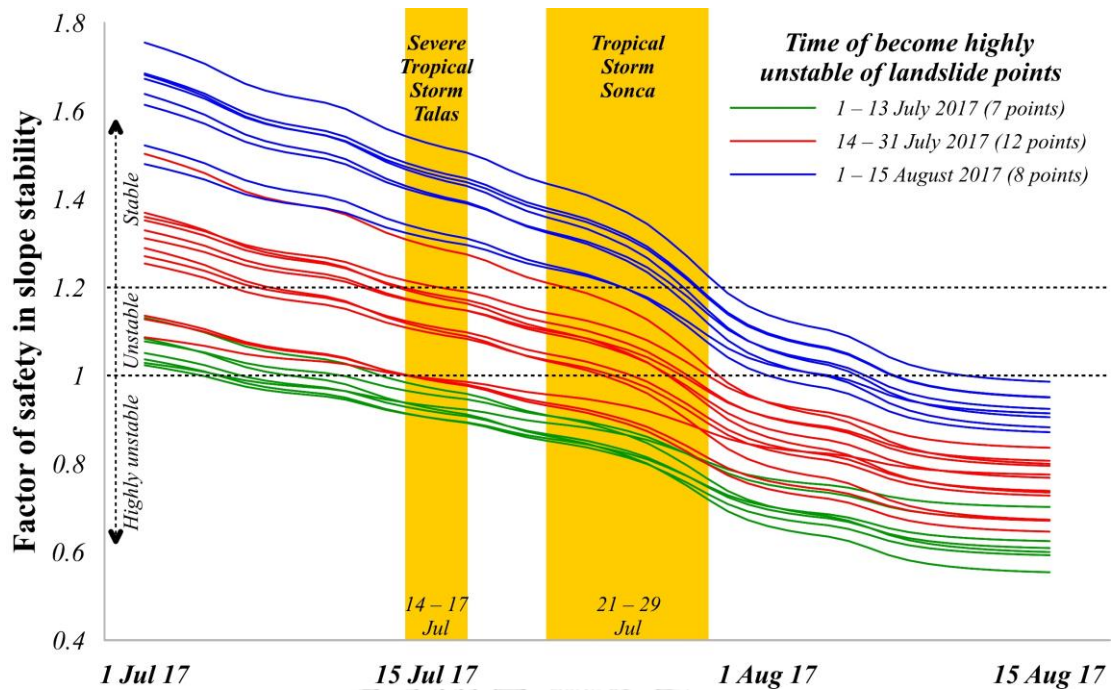
**Figure 5.7** Factor of safety in slope stability of 27 unstable locations in the Huai Nam Phung subbasin from 1 July to 15 August, 2017 due to two tropical storms (Talas and Sonca)

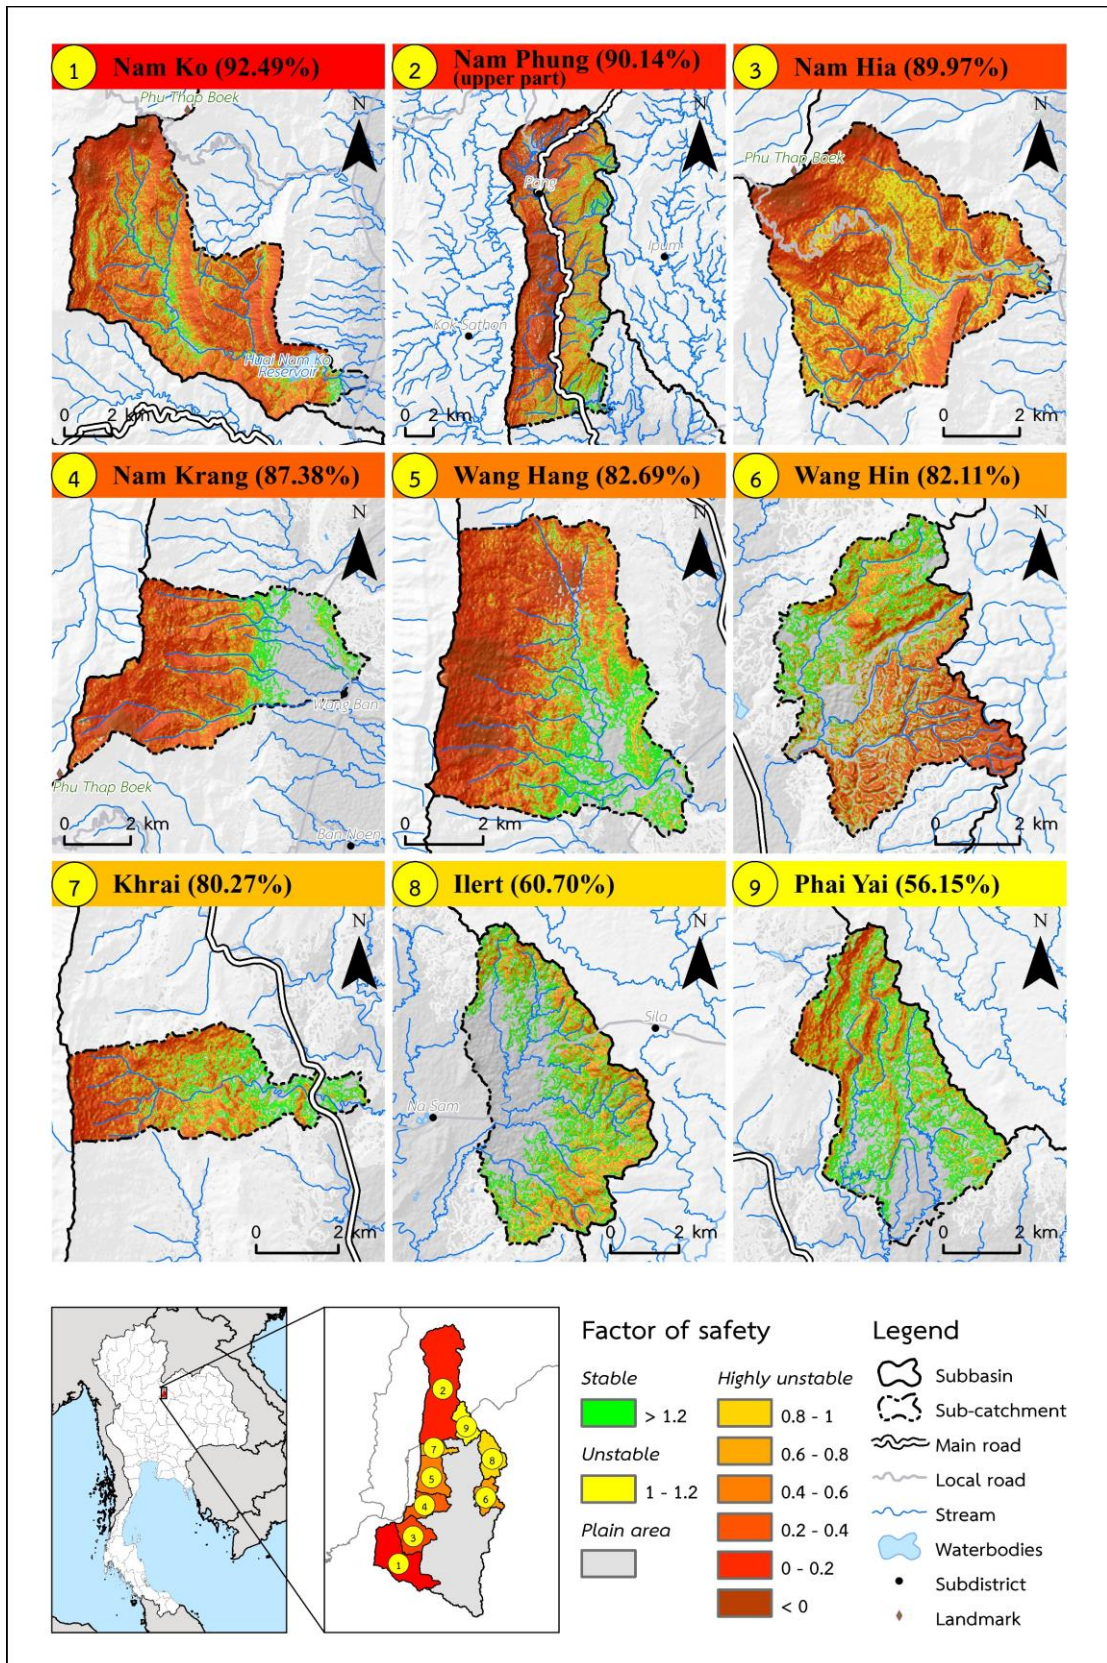
**Figure 5.9** Factor of safety in slope stability in the areas with slope higher than 6% in 9 sub-catchments of the Huai Nam Phung subbasin on 30 October, 2017

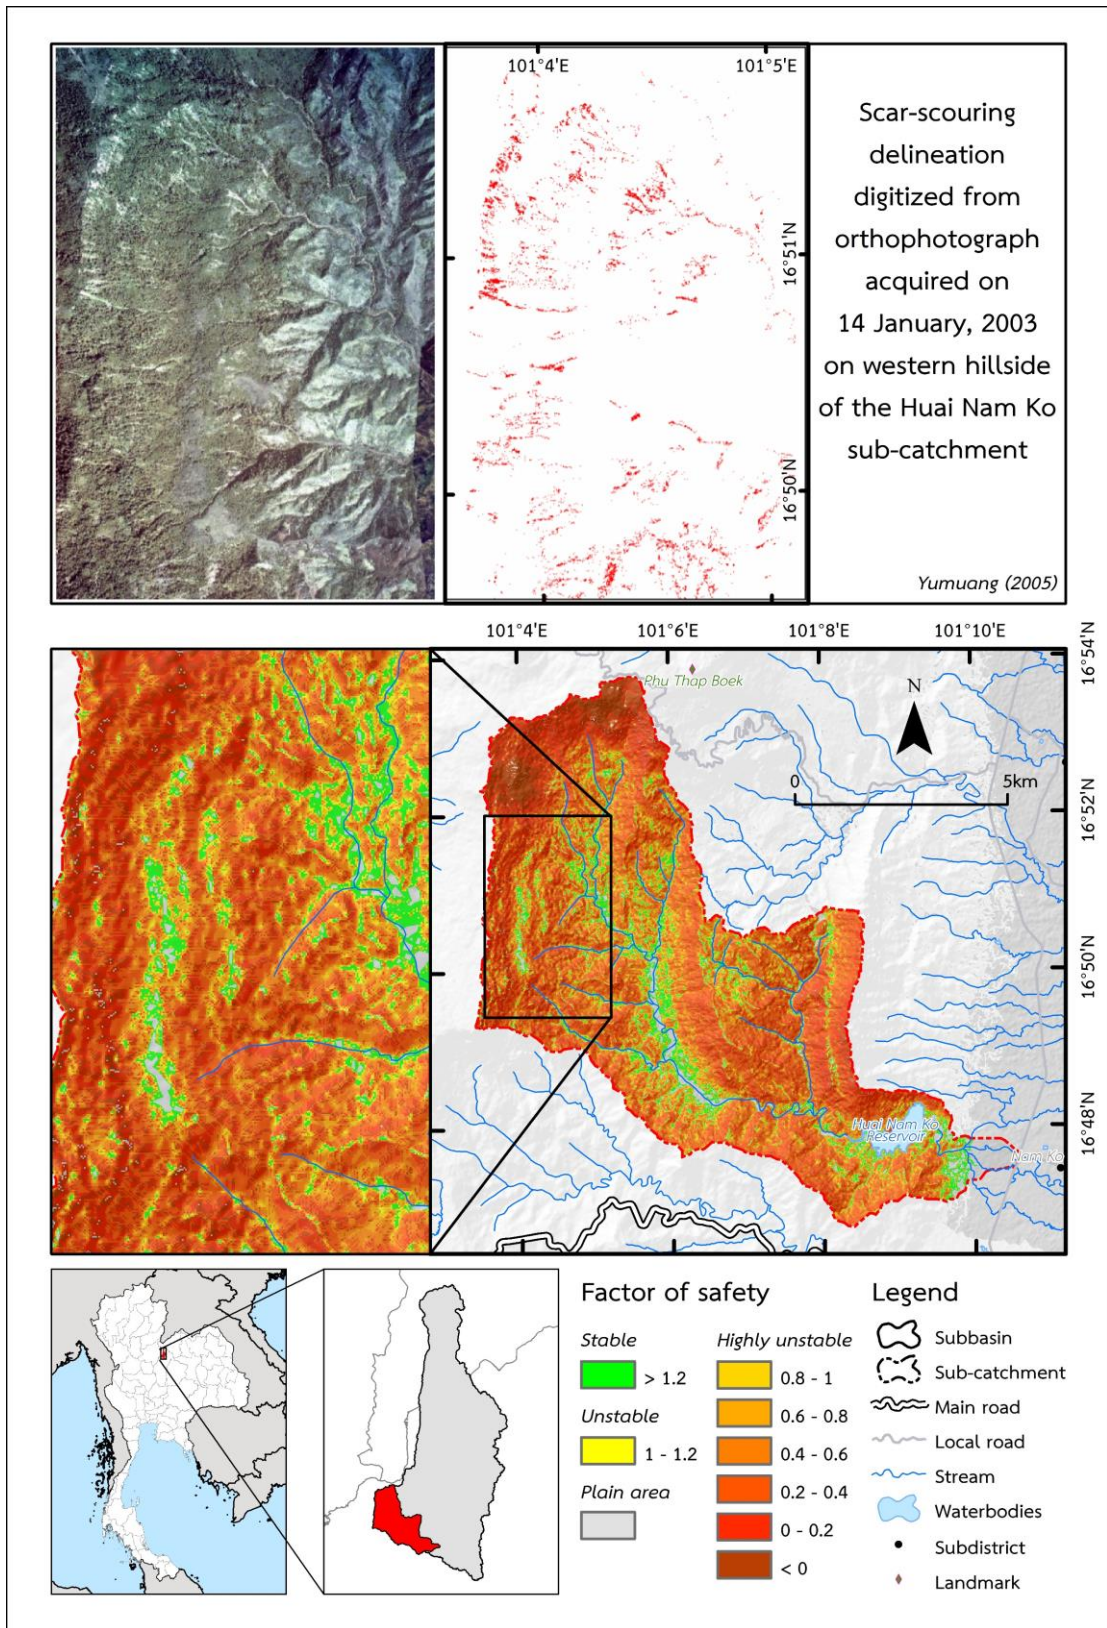
**Figure 5.10** Slope stability map on 30 October, 2017 and scar-scouring on 14 January, 2003 of Yumuang (2005) in the western hillside of the Huai Nam Ko sub-catchment

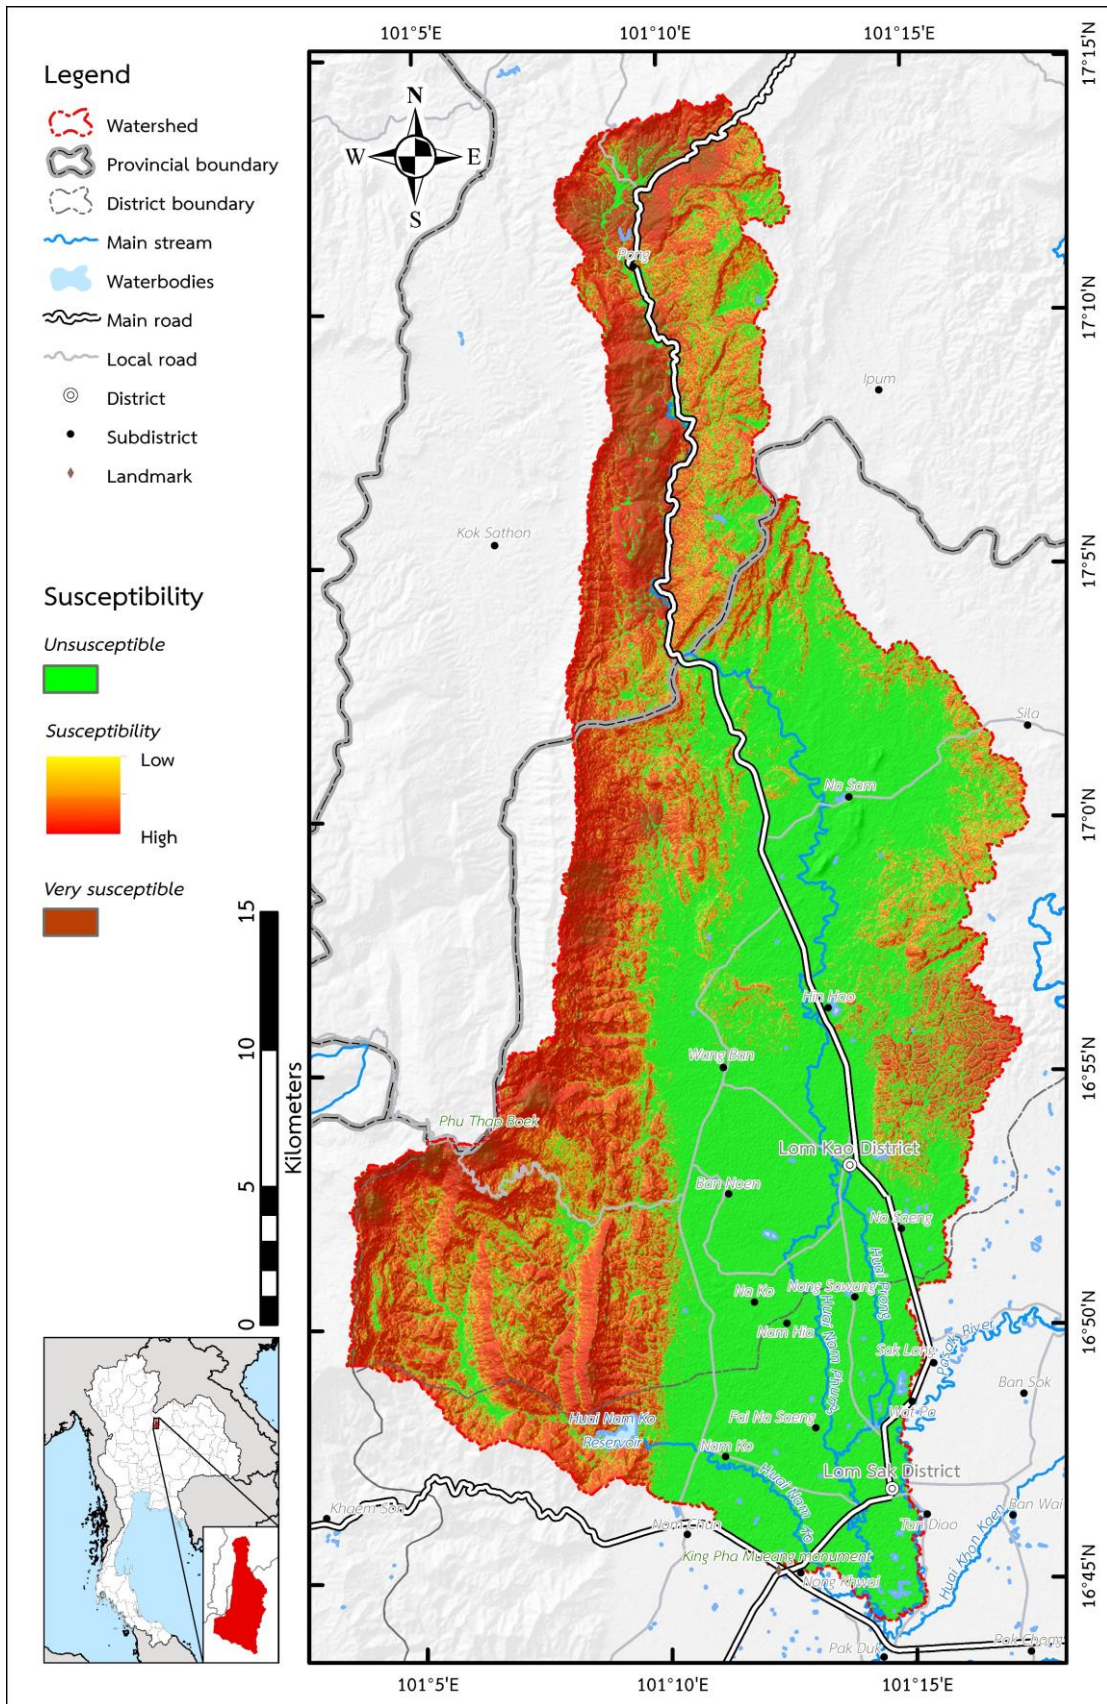
**Figure 5.12** Shallow landslide susceptibility map of the Huai Nam Phung subbasin
