CHAPTER III

DISCUSSION

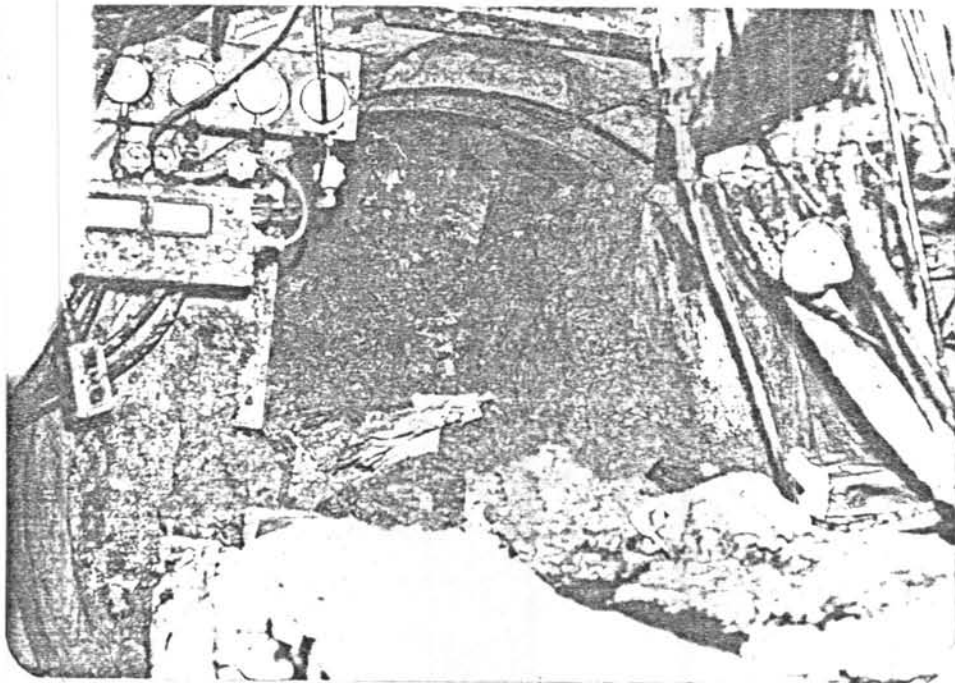
Fig. 71 The failure of tunnel face from the unsuitable tunnelling machine

The shield tunnelling machines are selected in accordance with the soil condition, the sufficient geological survey is indispensable, Fig. 71 shows the failure of tunnel face from the unsuitable shield machine:

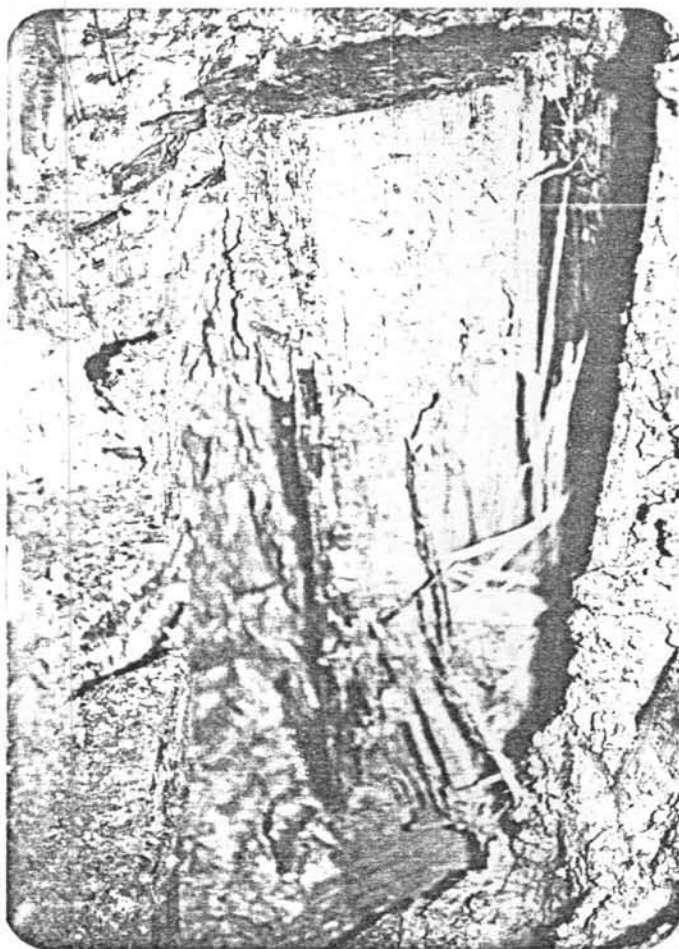
Fig. 72 The unforeseen obstruction in tunnel alignment

Obstruction such as pile as shown in Fig. 72 must be eliminated from the tunnel alignment.
